APPLICATION FORM

CULVERT REPLACEMENT MUNICIPAL ASSISTANCE GRANT APPLICATION FORM

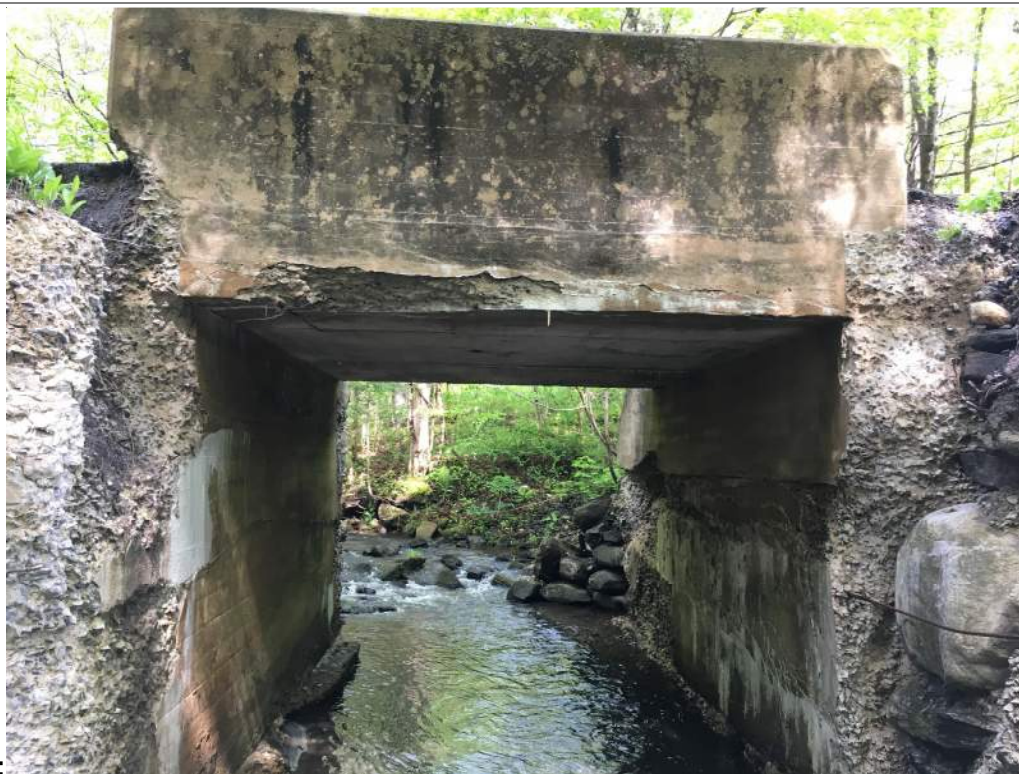
i. Road Over Culvert:

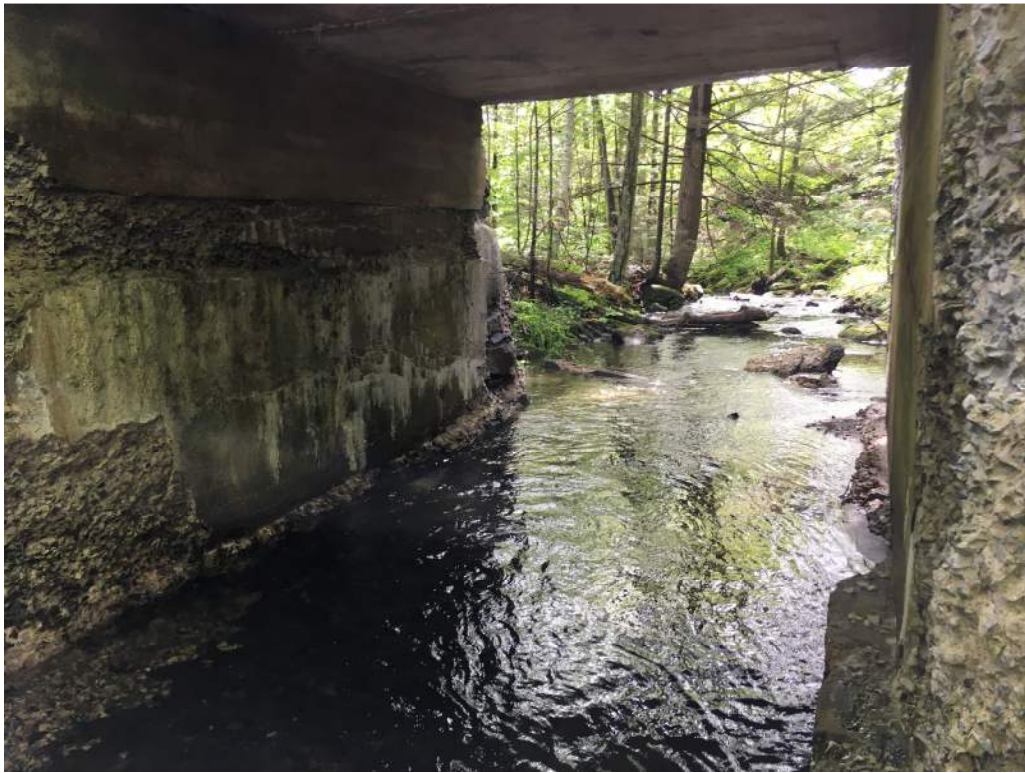
iii. Upstream of Culvert:

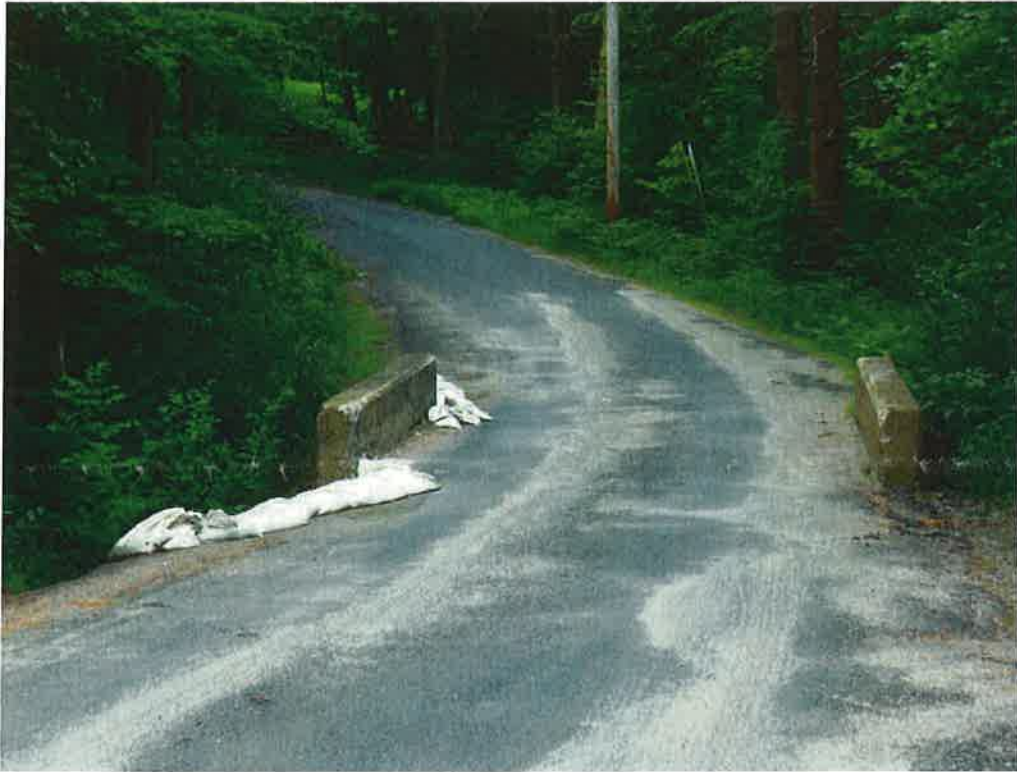
Photo 1: North approach. Note, sandbags at failed slopes.

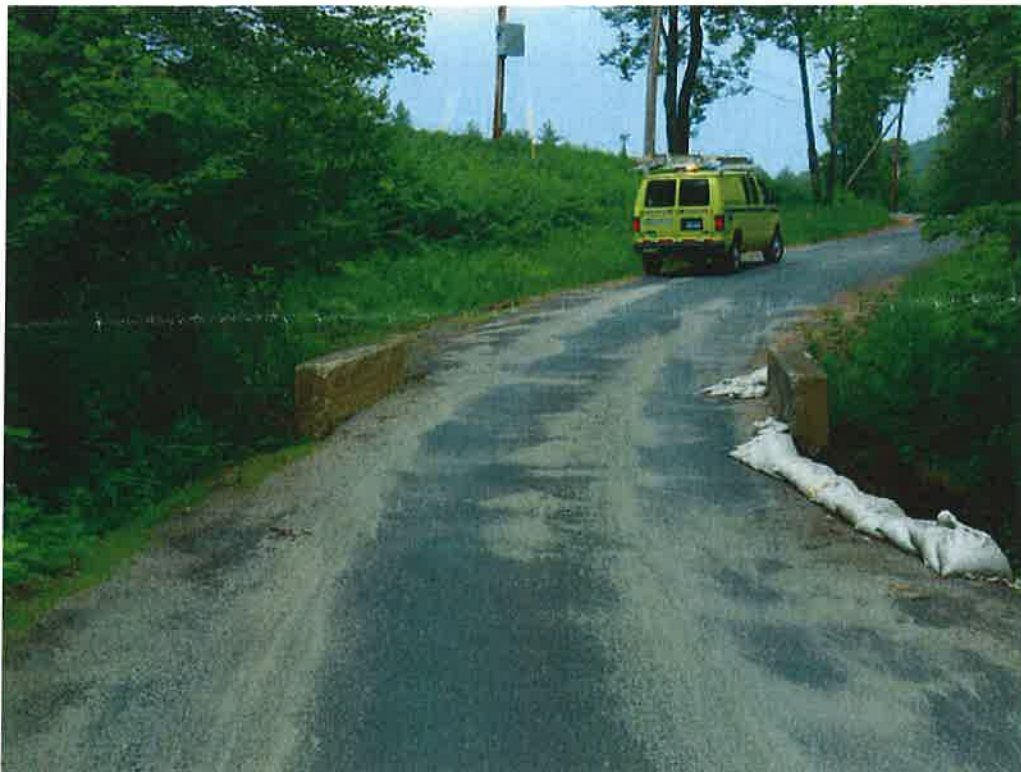
Photo 2: South approach. Note, sandbags at failed slopes.

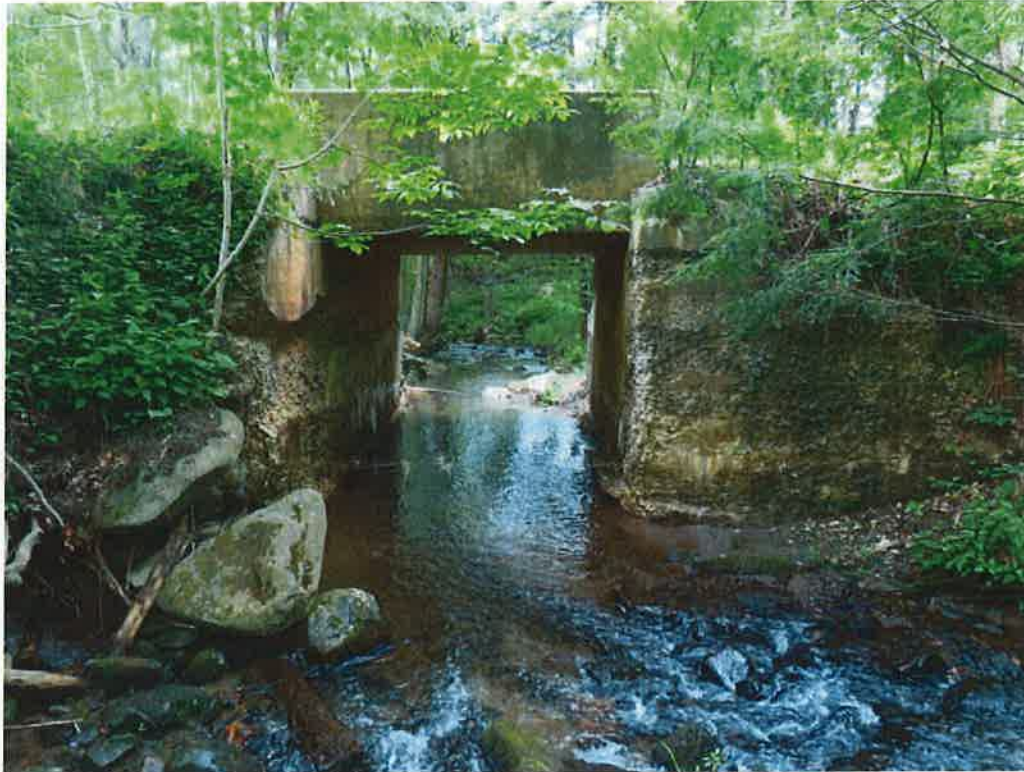
Photo 3: West elevation. Note, displaced stones and severe scaling of wingwalls.

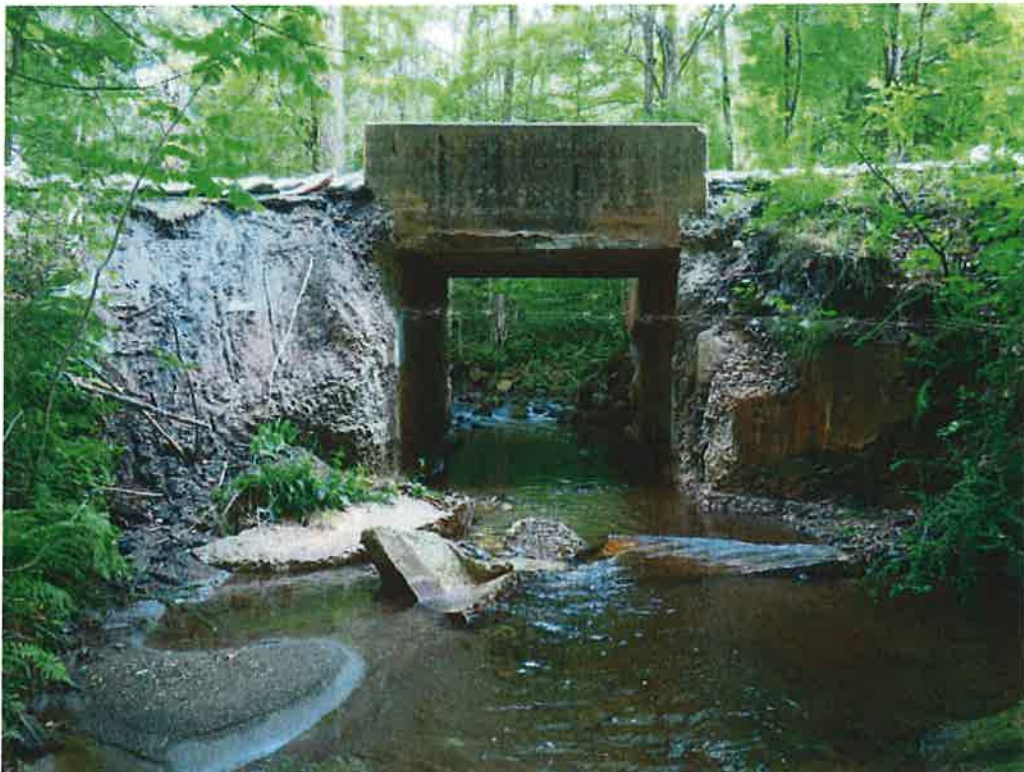
Photo 4: East elevation. Note, failed wingwalls in the channel.

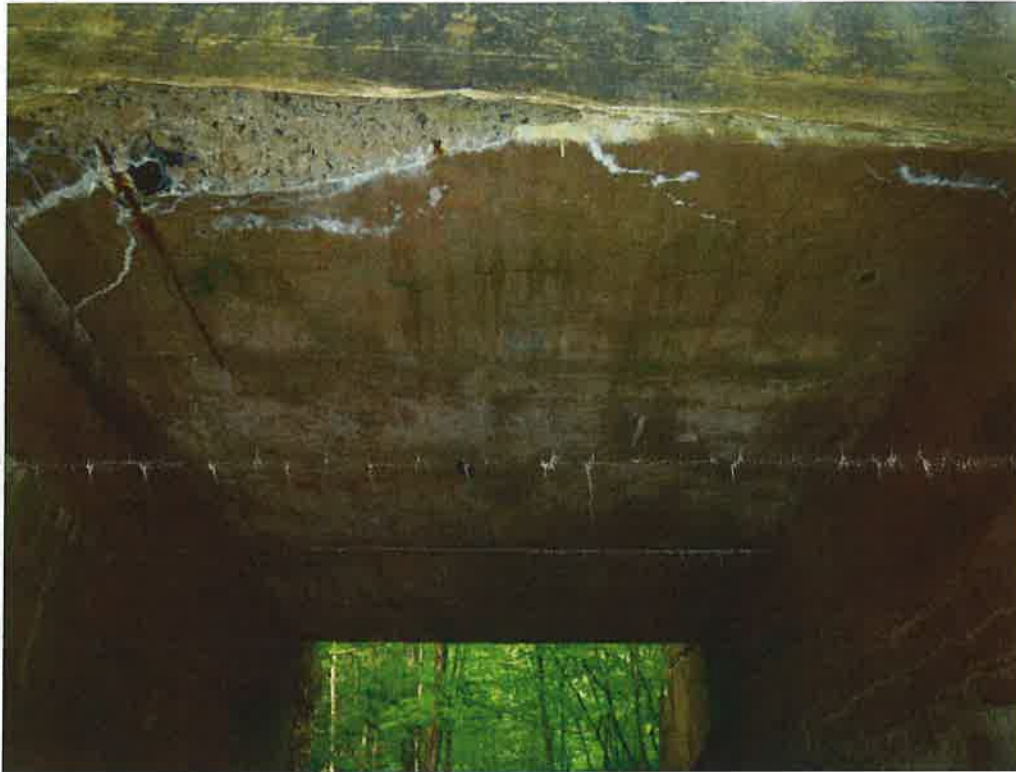
Photo 5: General underside view, looking west. Note, spalled area along the east edge.

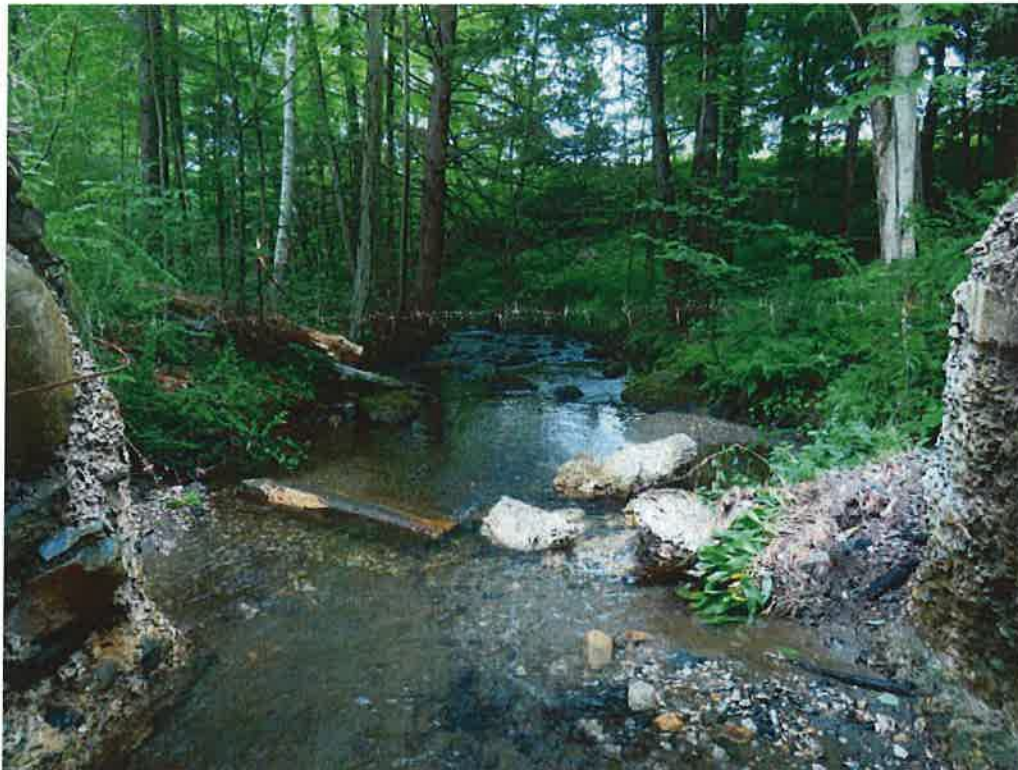
Photo 6: Downstream view. Note, failed wingwalls in the channel.

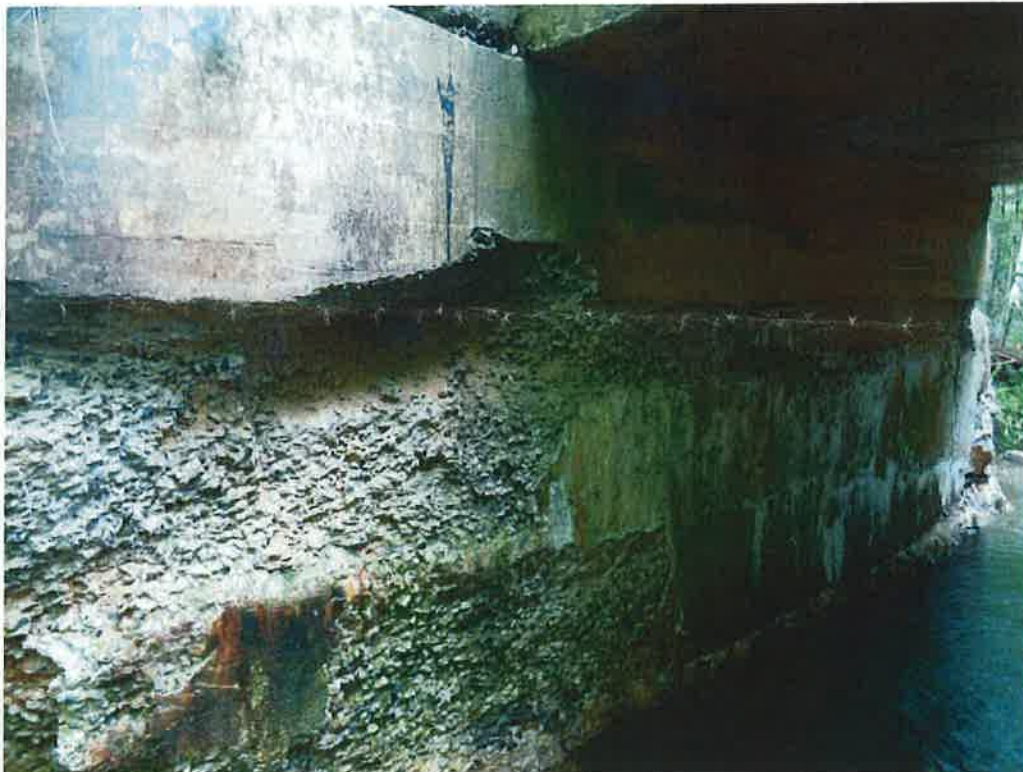
Photo 8: North breastwall with severe scaling, cracking and efflorescence.

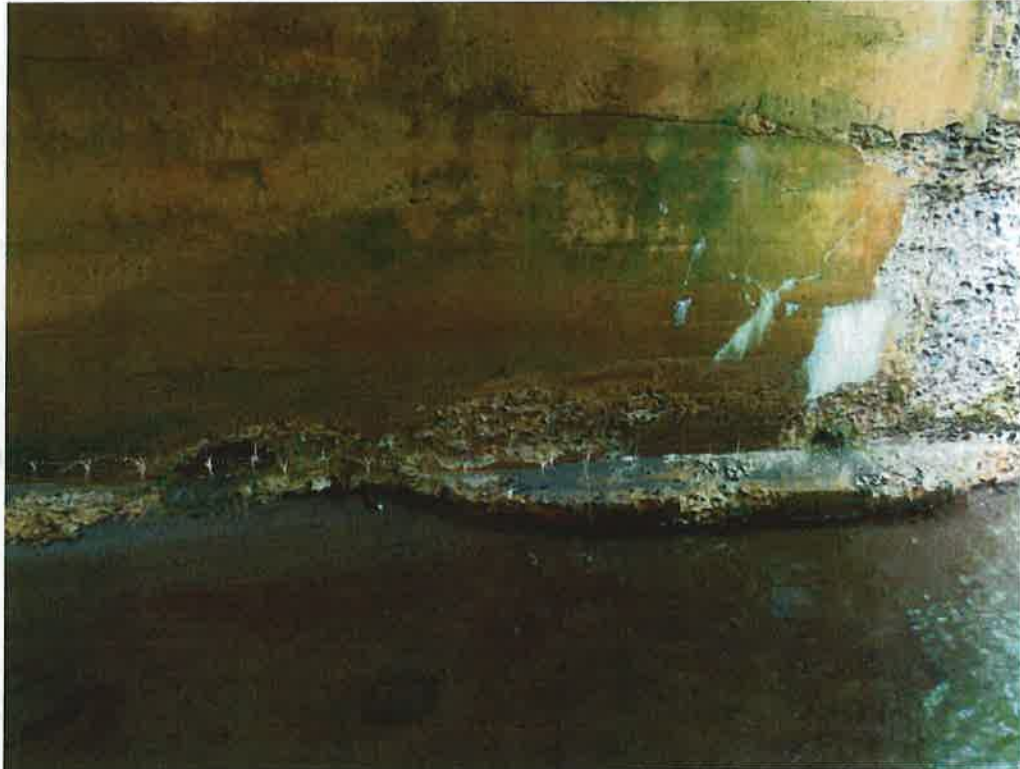
Photo 9: South breastwall with exposed footing and voids.

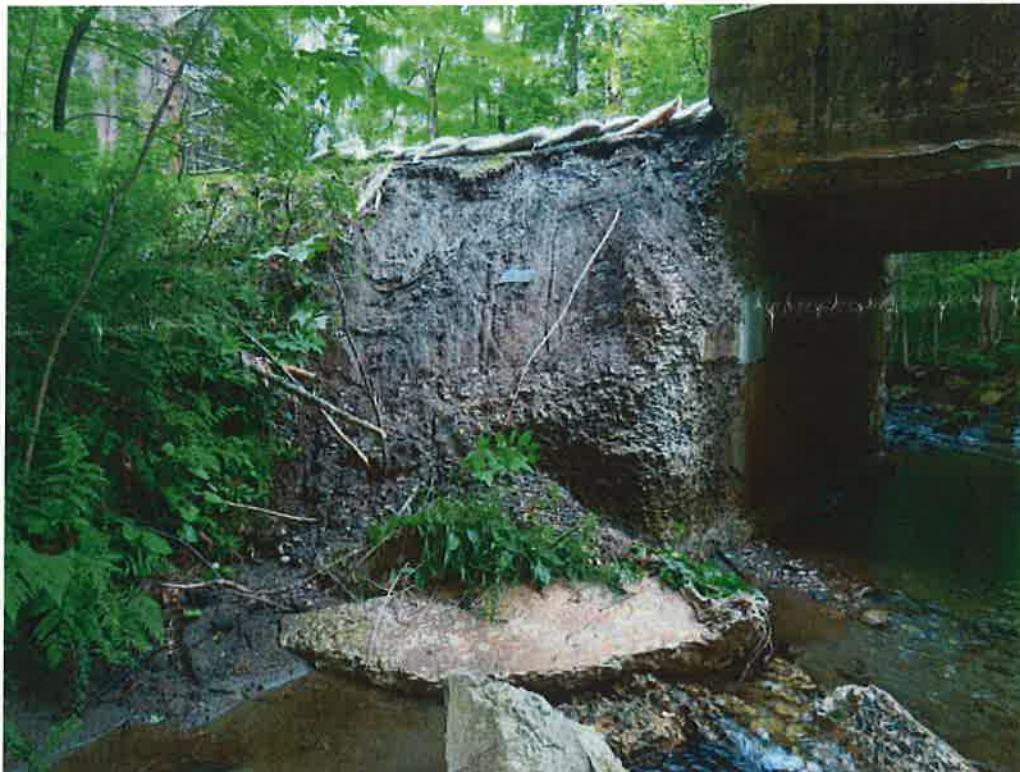
Photo 10: Close-up of southeast wingwall, failed.

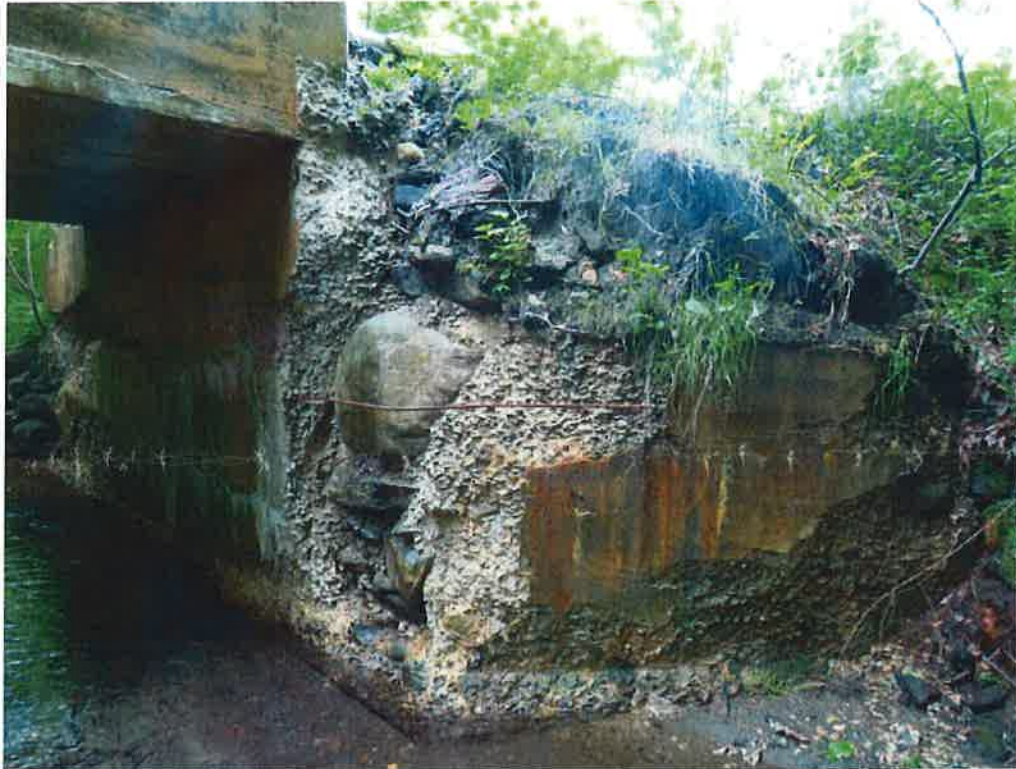
Photo 11: Close-up of northeast wingwall, partially failed. Also note, footing exposed and scaled.

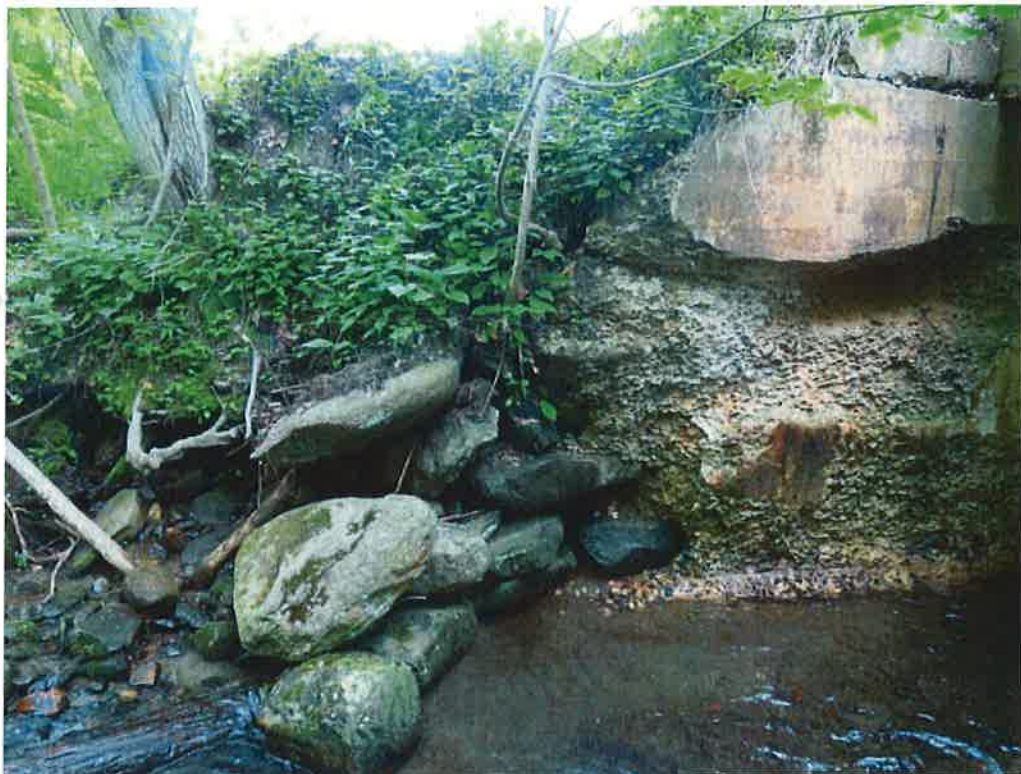
Photo 12: Northwest embankments with displaced stones & embankment erosion. Also note, wingwall/breastwall with severe scaling.
