# Building Climate Resiliency in the Clesson Brook Watershed

Findings from the Fluvial Geomorphic Assessment

February 14<sup>th</sup>, 2023

Buckland Selectboard

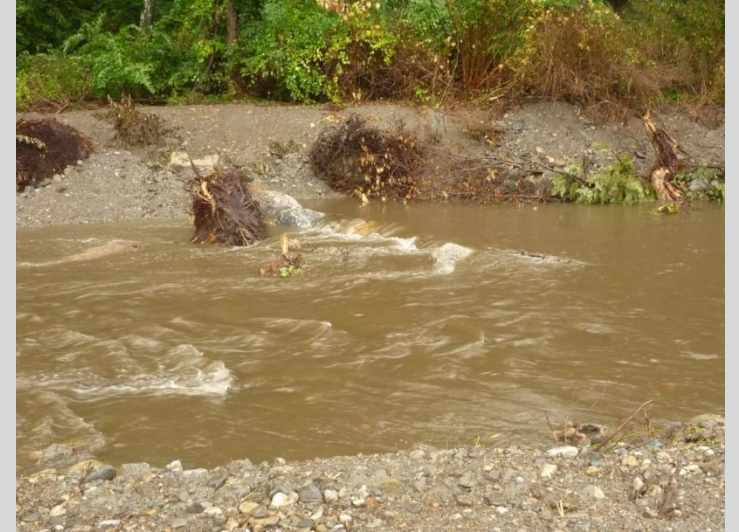
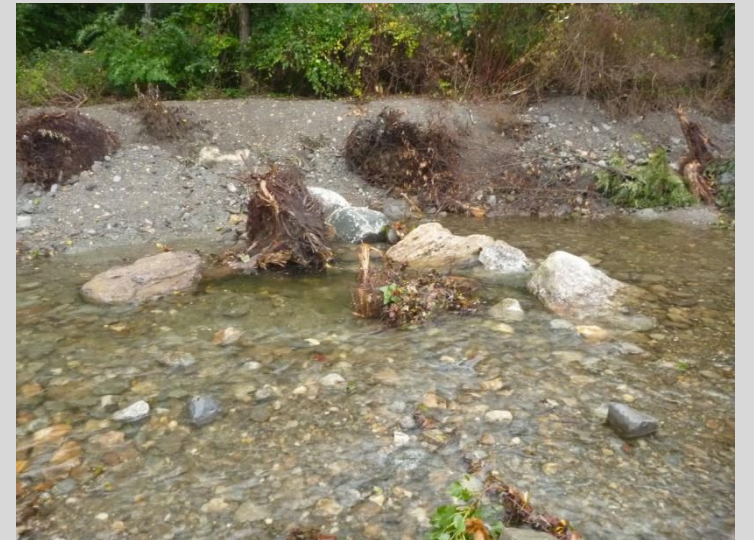
*Example of a completed restoration project: boulder deflectors positioned in stream to help slow the flow*

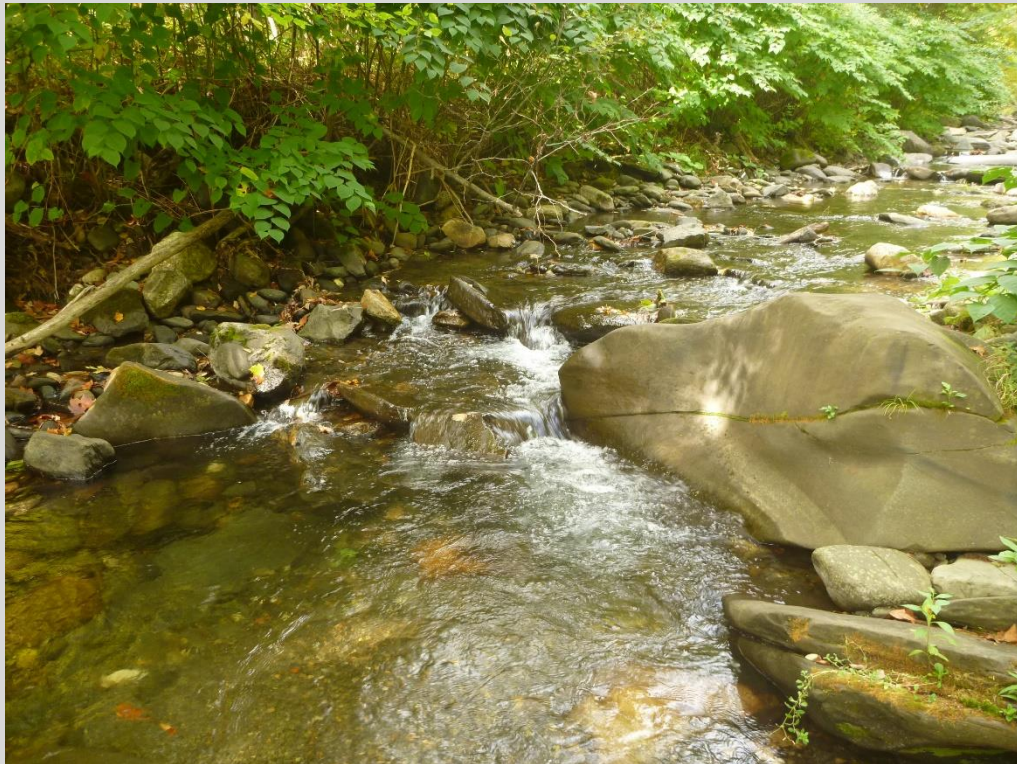
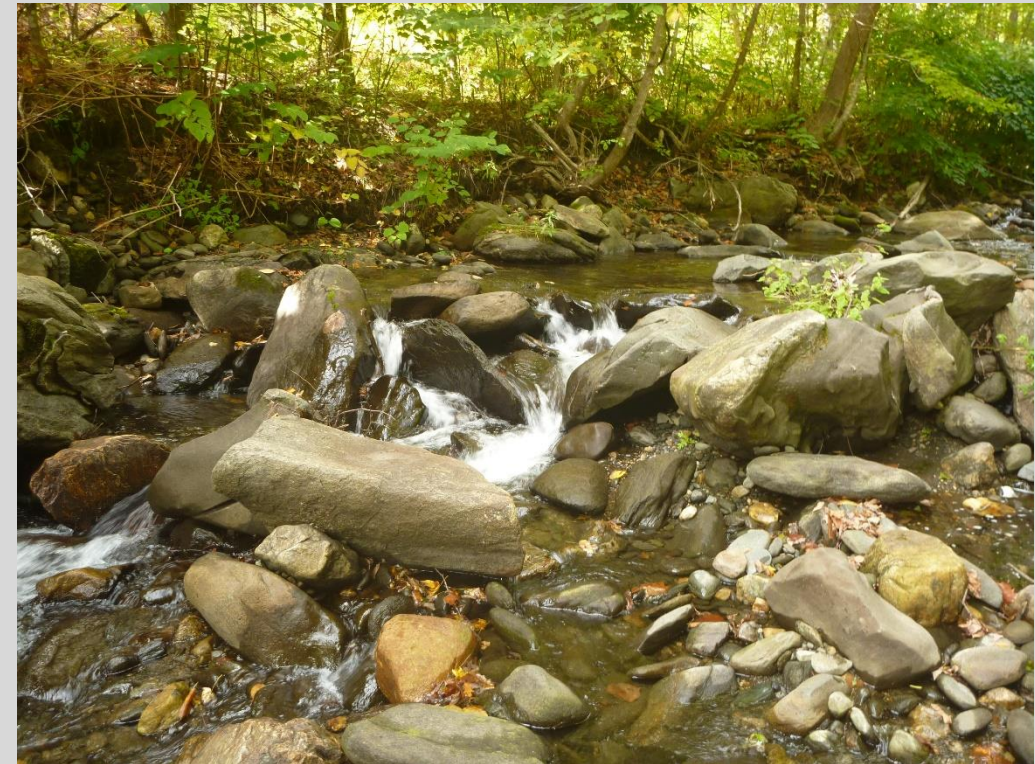
## Headcuts (knickpoints)

- 87 headcuts mapped along Clesson Brook
- Vertical instability following excessive sediment mobilization and deposition during TS Irene

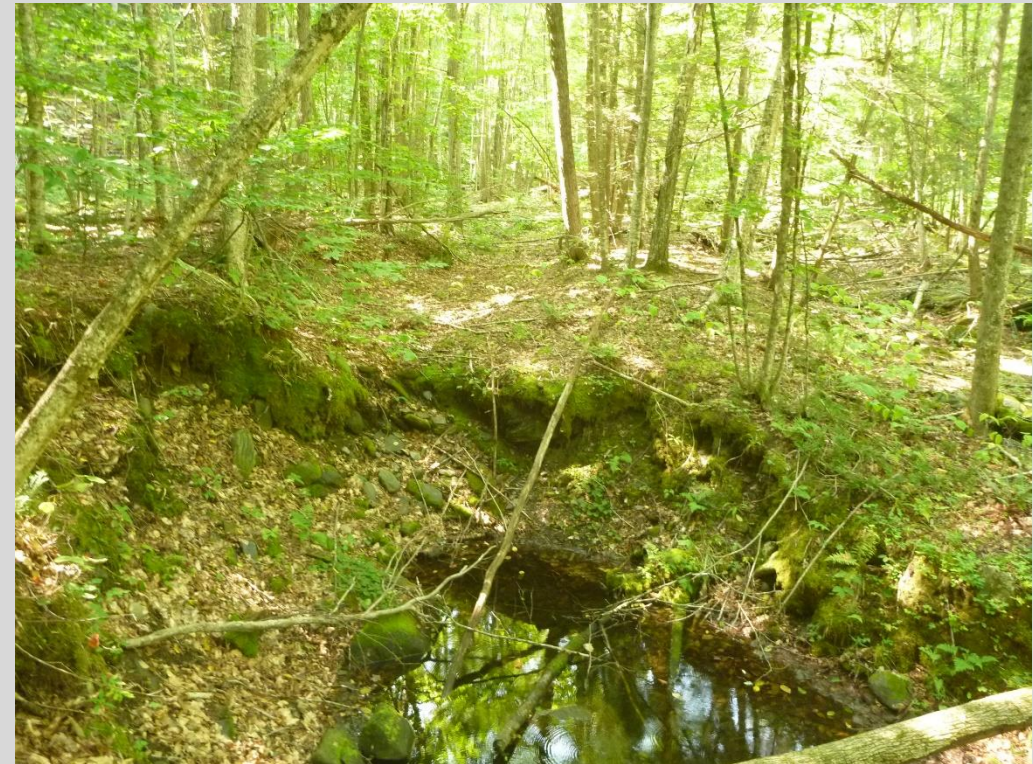
## Headcuts (knickpoints)

- In the 11 years since TS Irene, Clesson Brook and its tributaries have been adjusting to lower discharges (relative to TS Irene) and a higher sediment load
- Bed morphology in transition

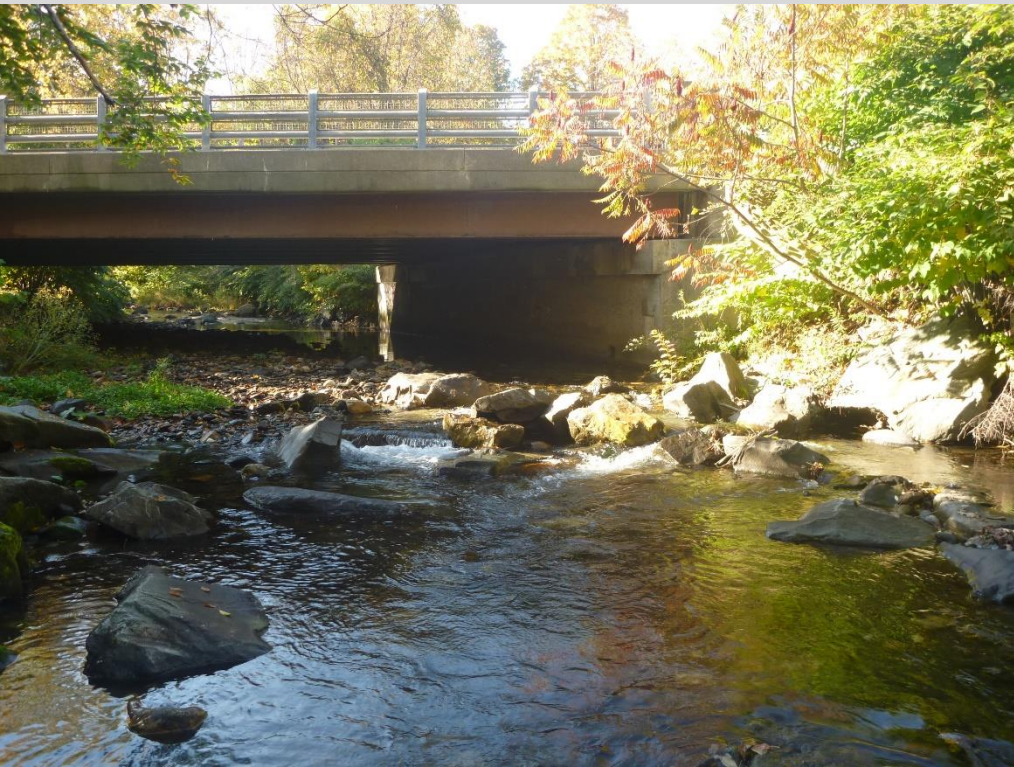
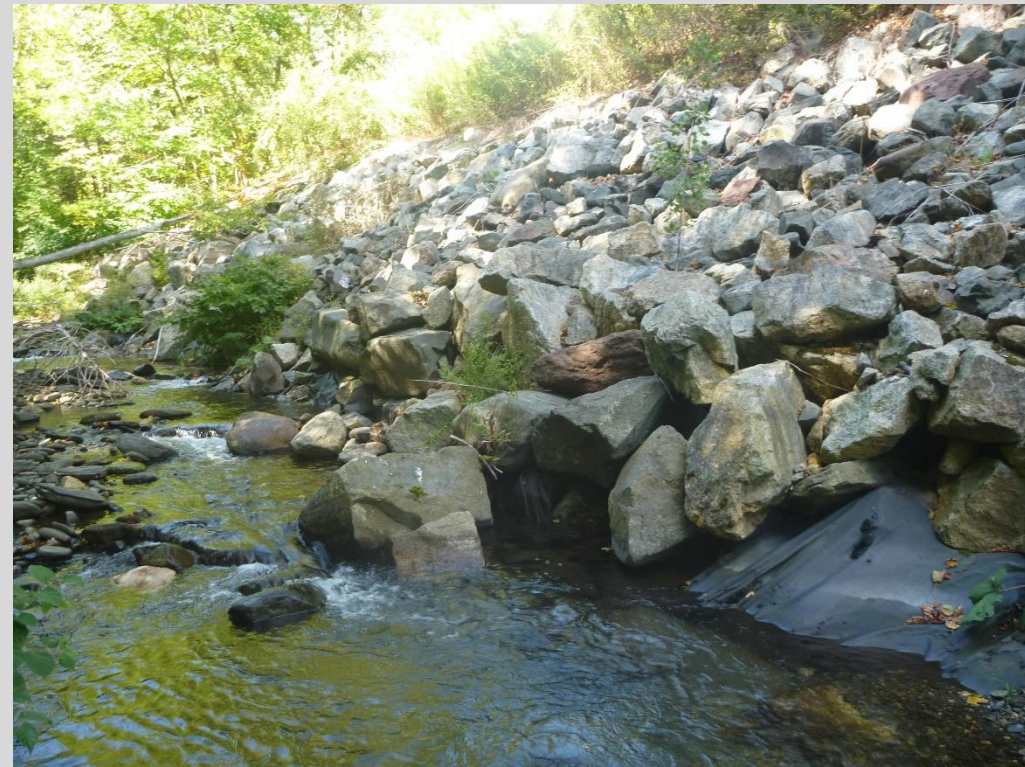
## Headcuts (knickpoints)

- Headcuts migrate upstream leaving a deeper channel (ie. more flow contained within channel and impaired floodplain connection)
- Vertical instability leads to lateral instability and potential undermining of infrastructure

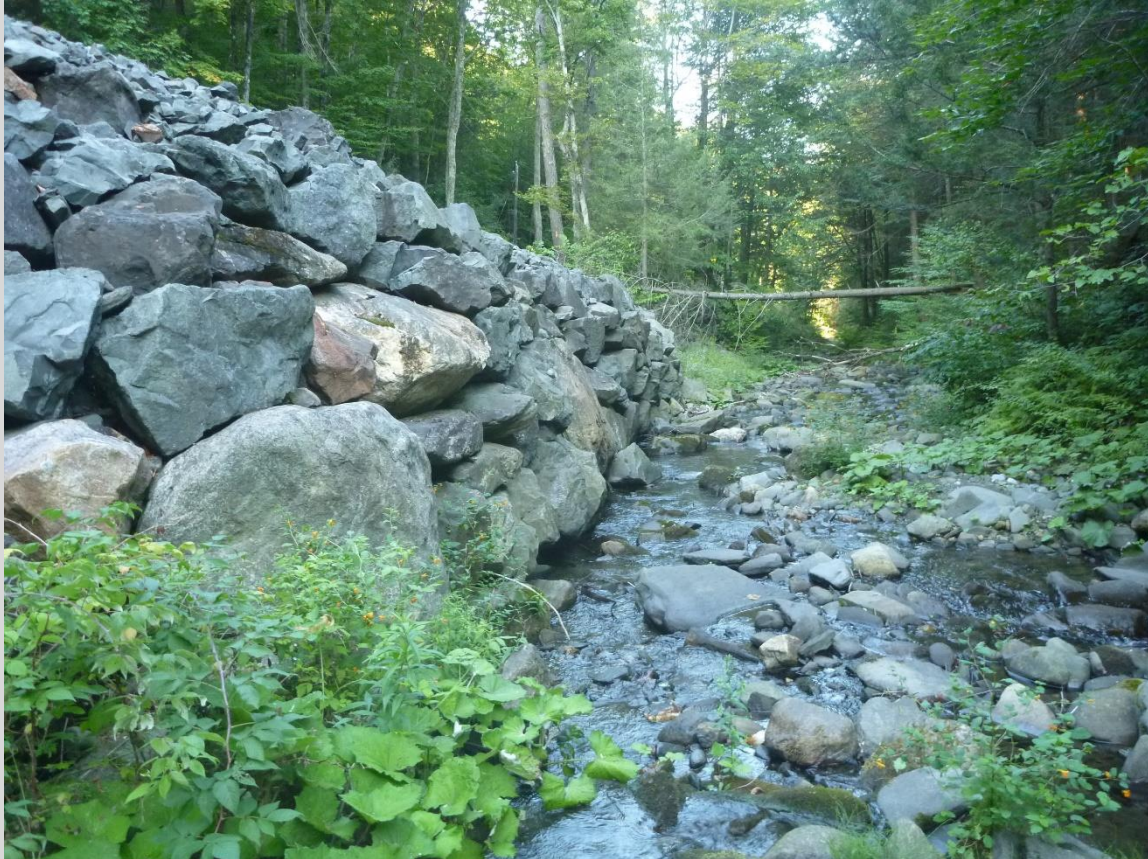
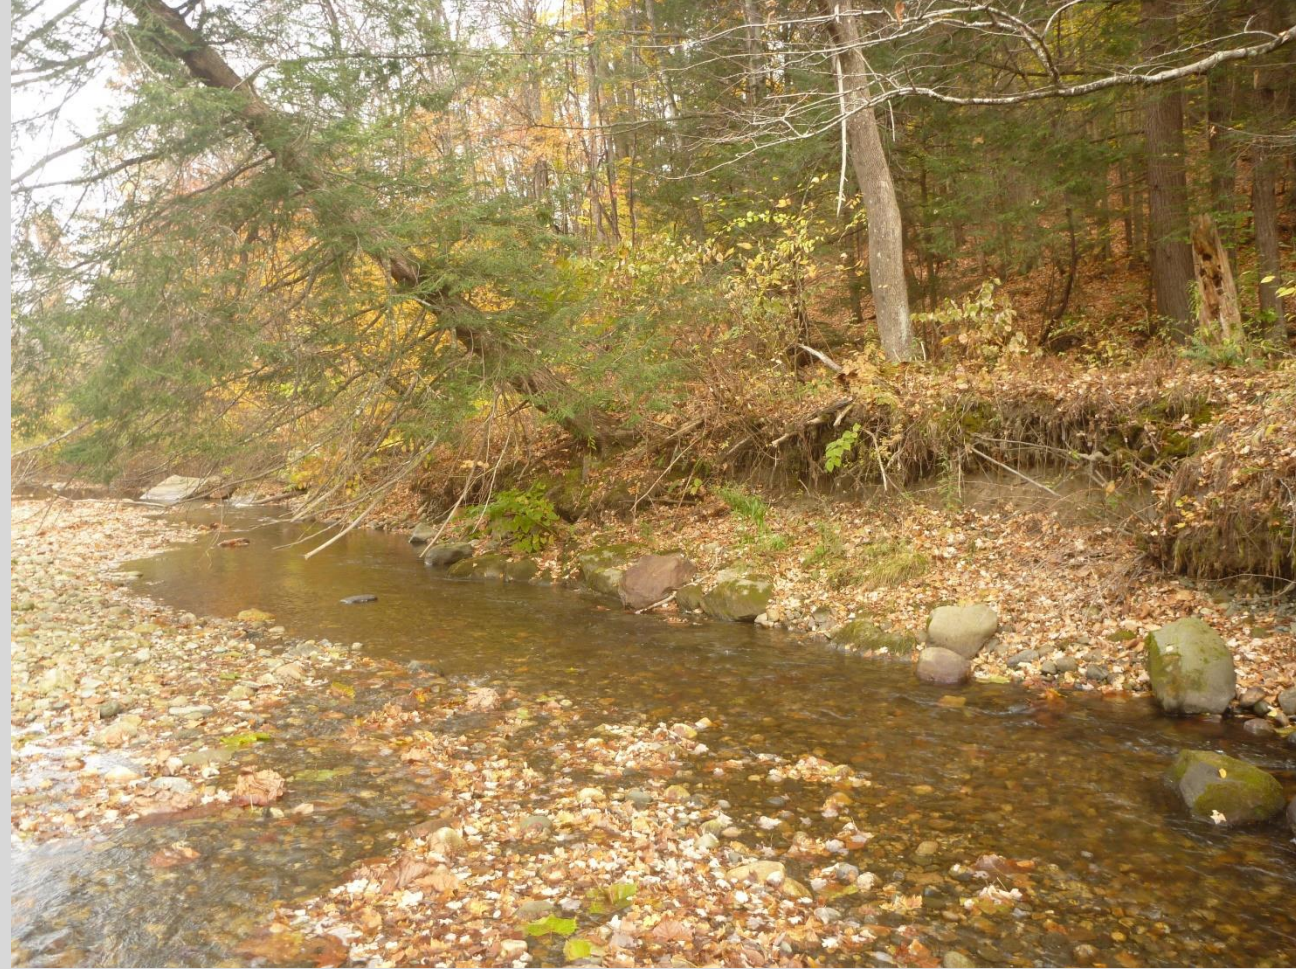
## Bank stability

- Eroding banks – 20%
- Armored banks – 15%

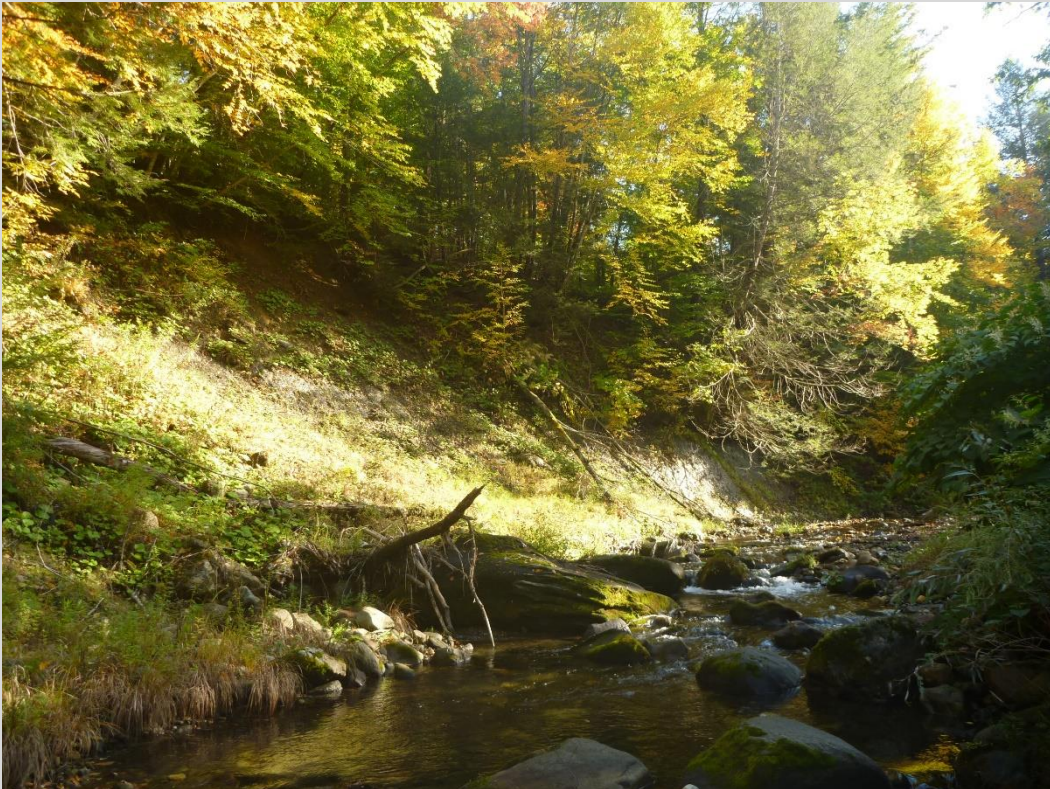
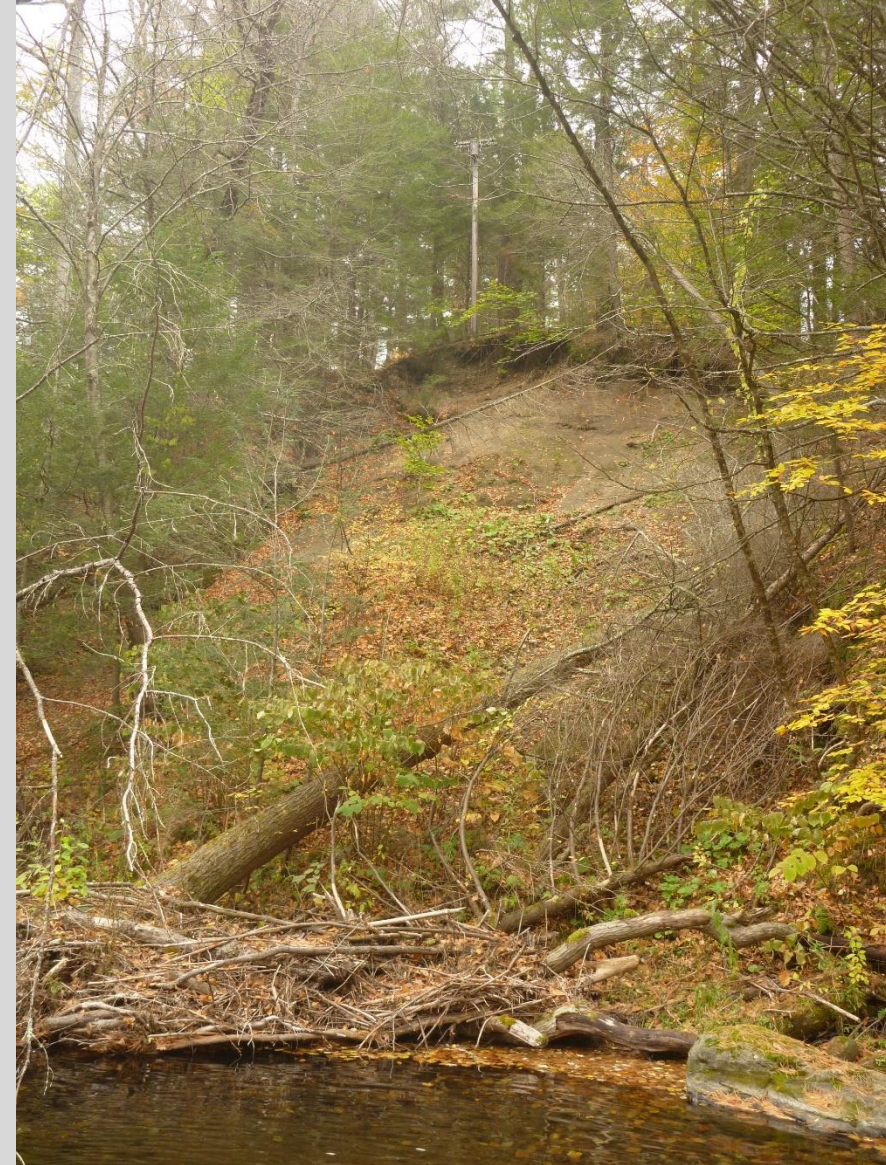
## Mass failures (landslides)

- Major sediment source – sediment loading and water quality impairments
- 28 mapped – largest ~180 feet long and 40 feet high

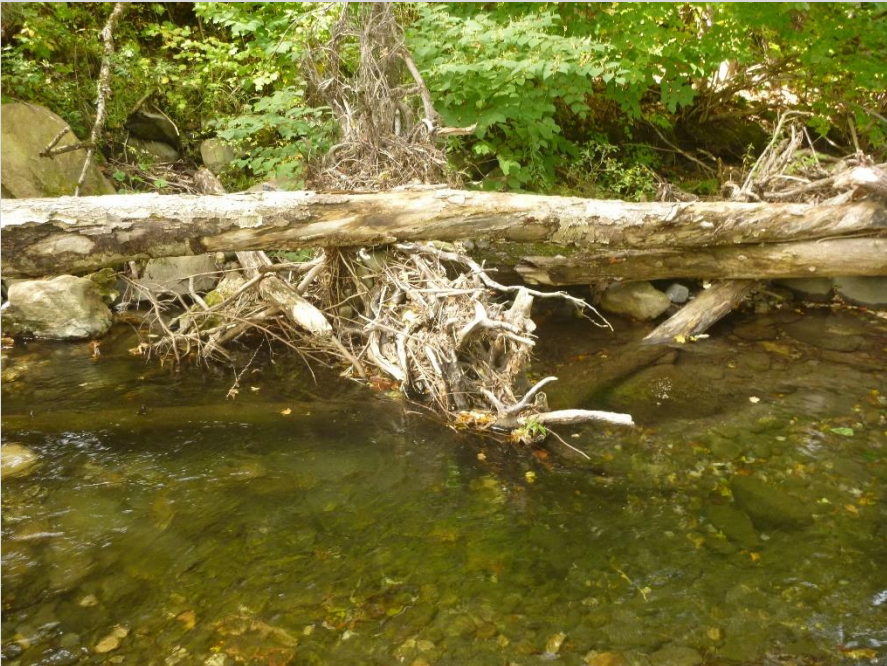
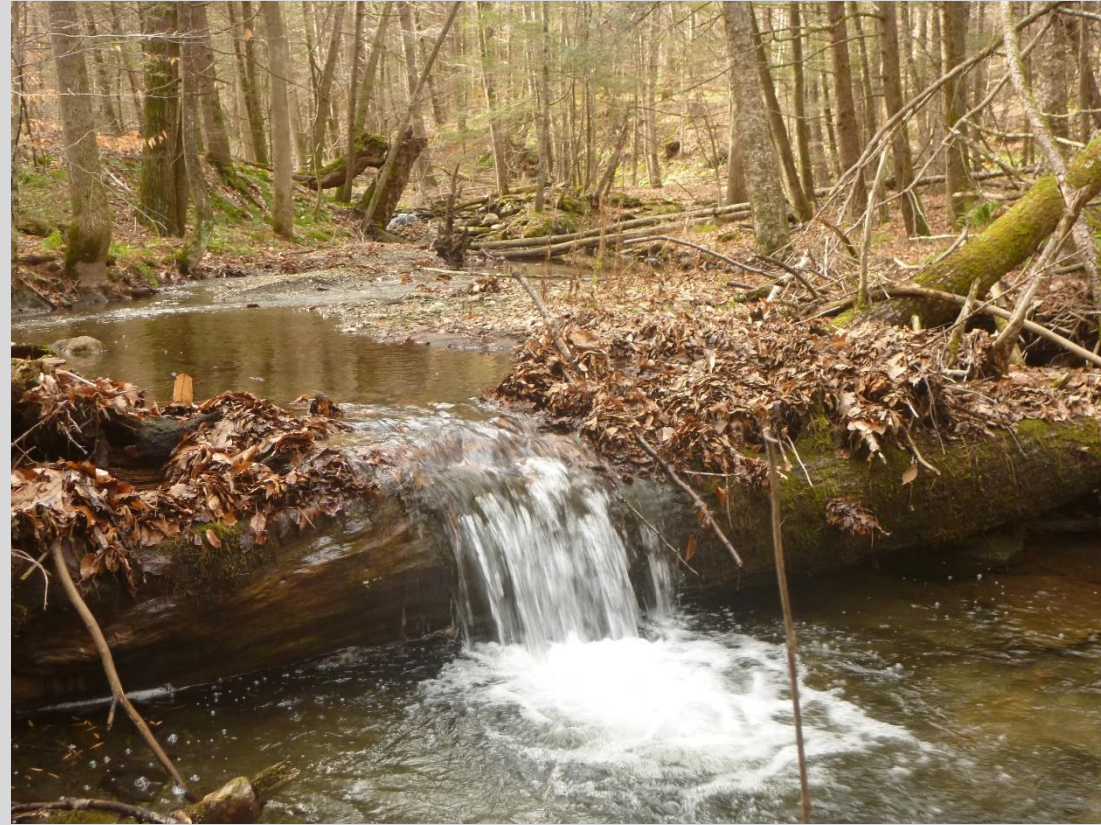
Individual pieces of wood and log jams mapped

- 1062 pieces
- 97 pcs/mile
- Natural conditions = 175 to 225 pcs/mile  
(McKinley et al., undated)

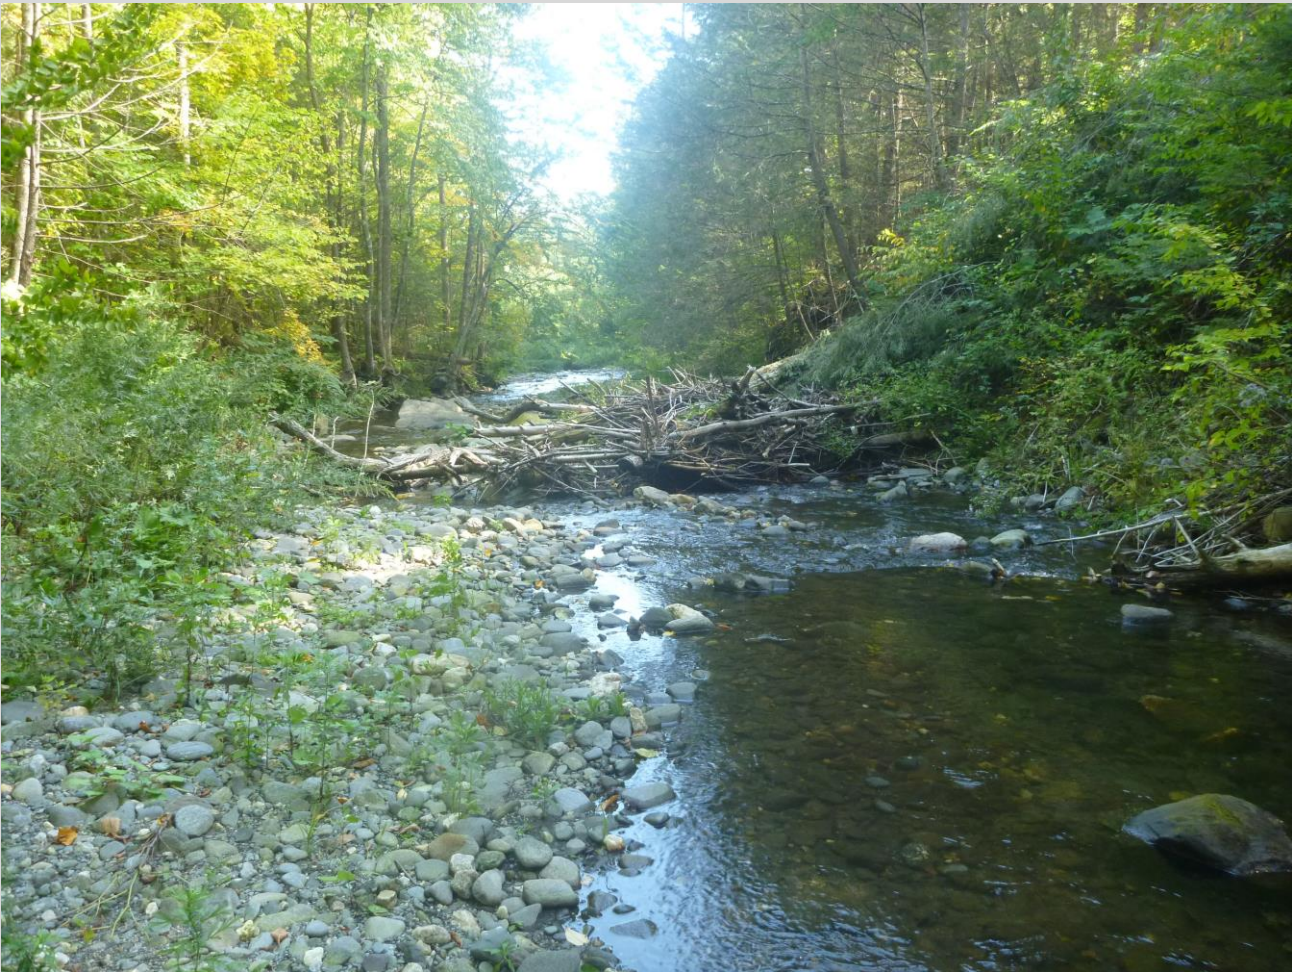
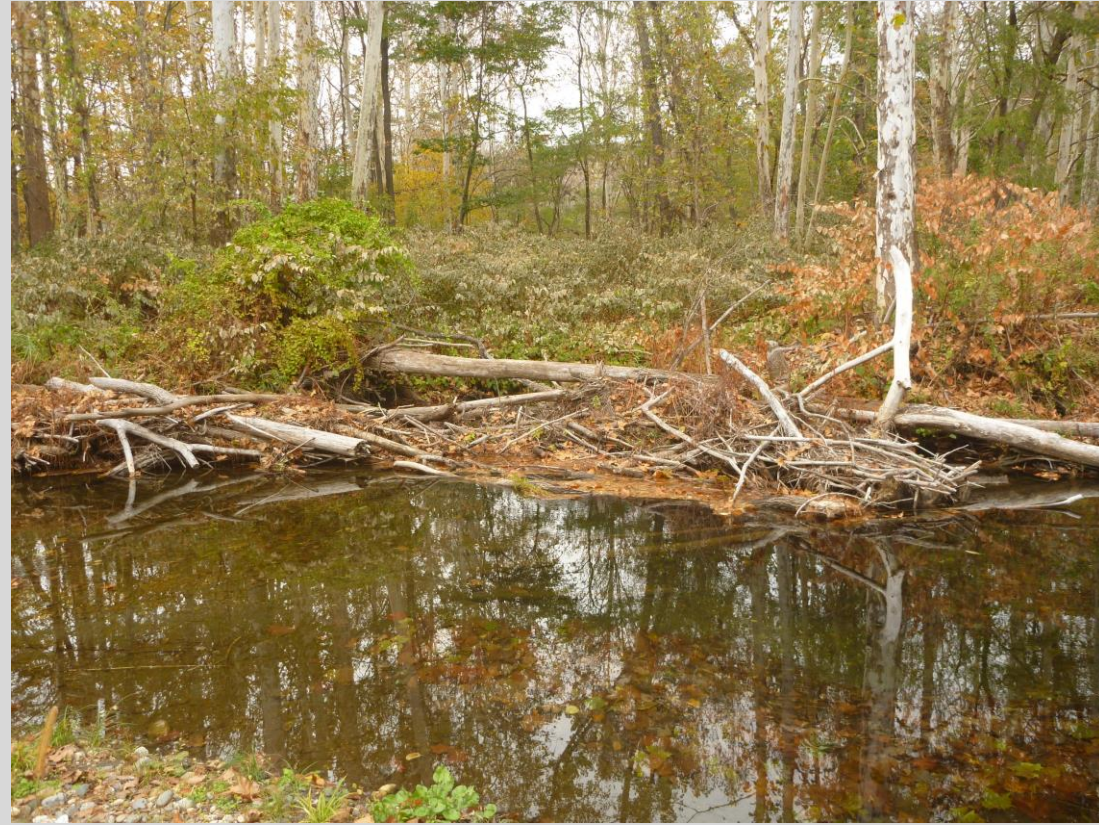
Log jams provide cover and encourage meander formation in previously straightened channels

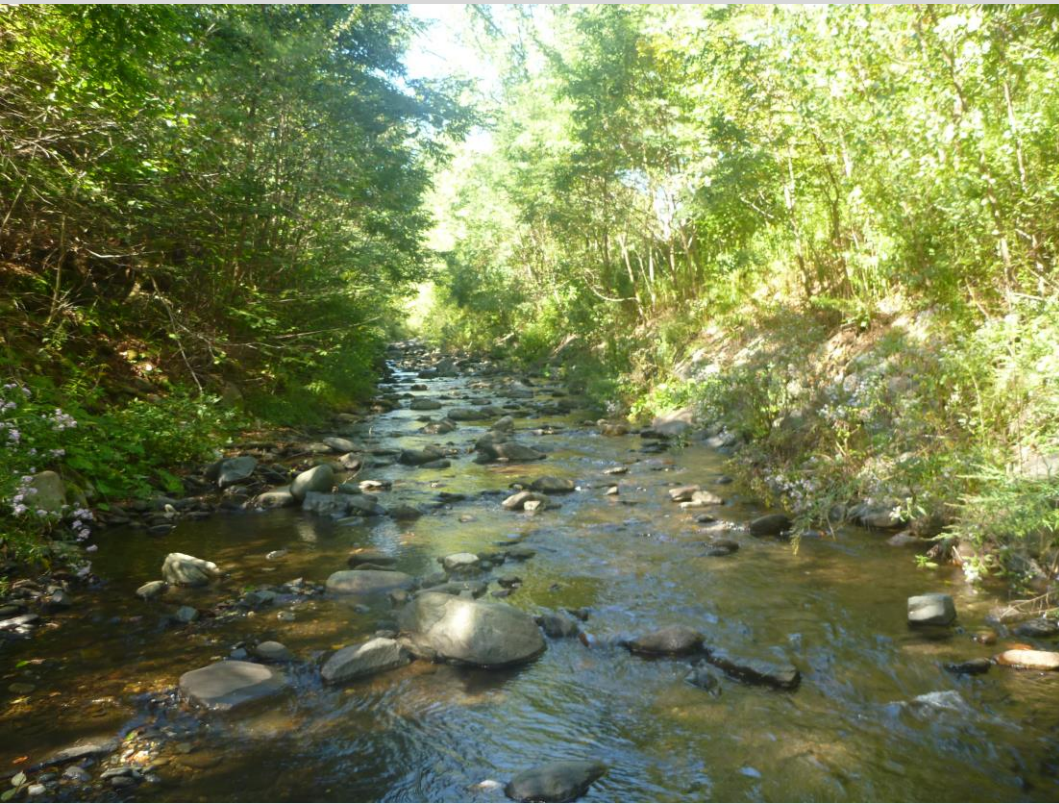
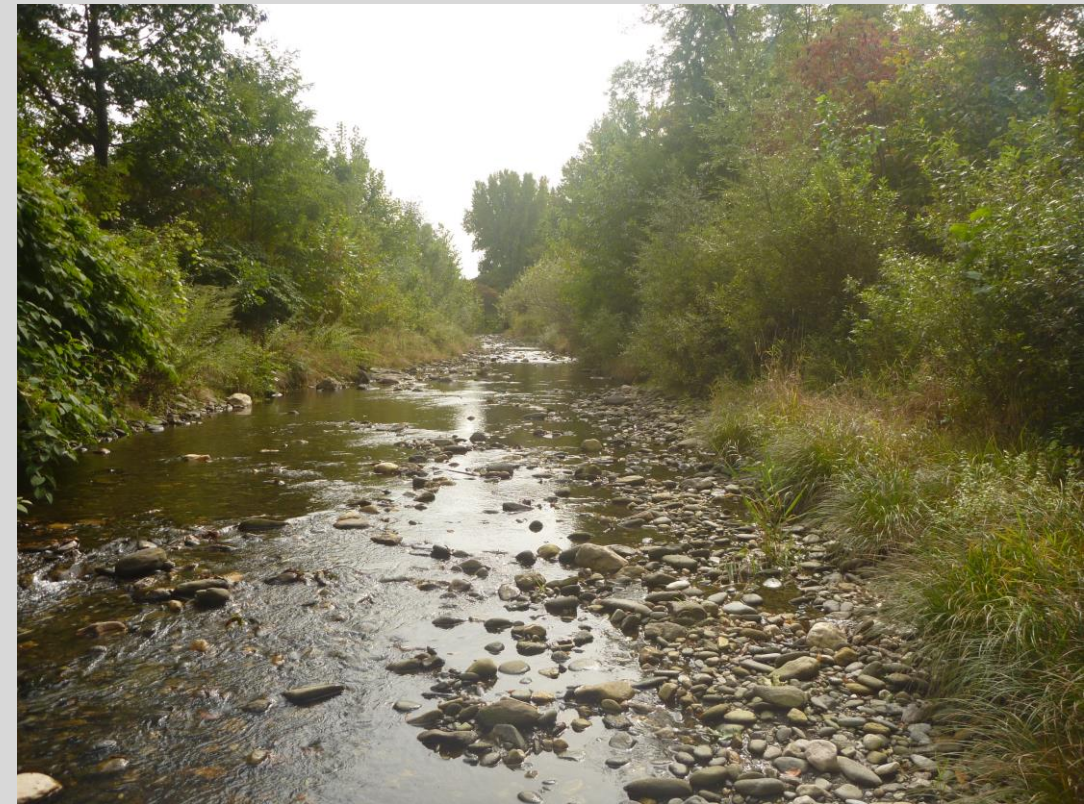
## Channel straightening

- Long segments of stream are artificially straightened
- Increased slope = increased velocities and capacity to transport sediment
- Wood is unevenly distributed

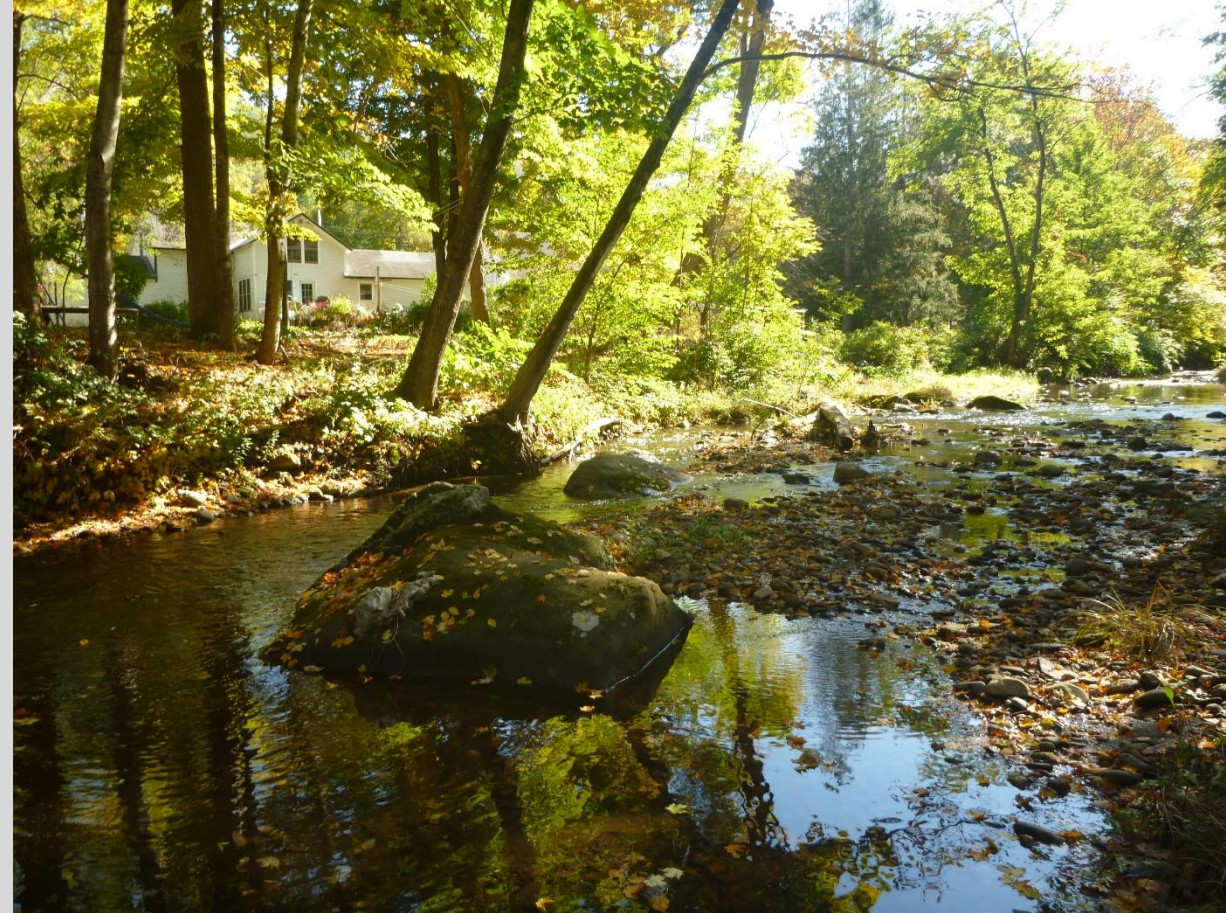
## Migration features and stream corridor encroachments

- Avulsions
- Side channels / flood chutes
- Braiding / anabranching
- Development / infrastructure within stream corridor
- Rt 112 and Clesson Brook Rd
- Berms / windrows
