Building Climate Resiliency in the Clesson Brook Watershed

GZA GeoEnvironmental

Community Open House – Summary of Project Findings June 7th, 2023

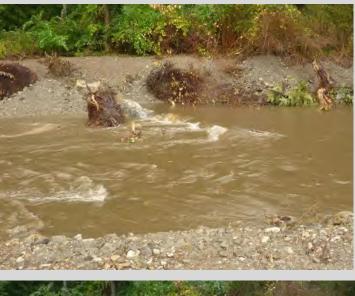
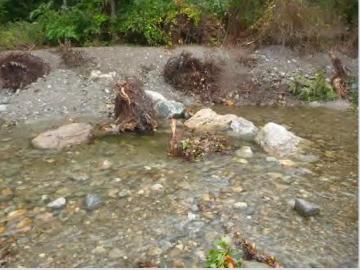
Example of a completed restoration project: boulder deflectors positioned in stream to help slow the flow

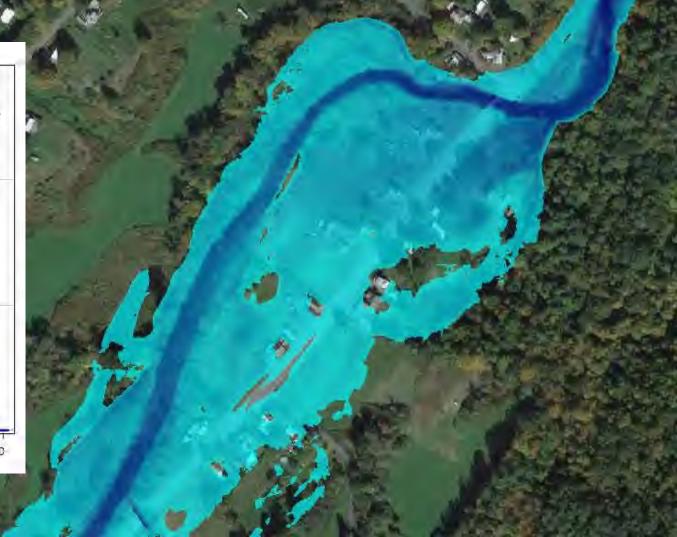
Hydraulic modeling of Clesson Brook2D HEC-RAS model

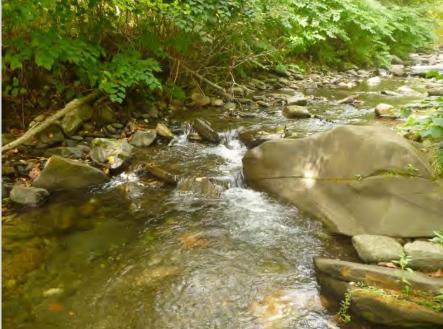
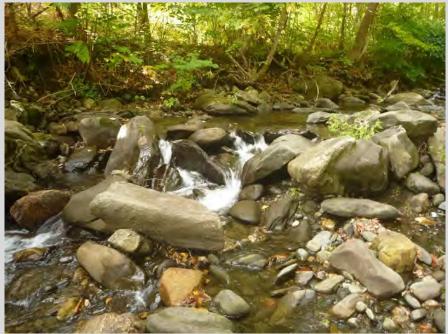
Headcuts (knickpoints)

- 87 headcuts mapped along Clesson Brook
- Headcuts migrate upstream leaving a deeper channel (ie. more flow contained within channel and impaired floodplain connection)
- Vertical instability leads to lateral instability and potential undermining of infrastructure

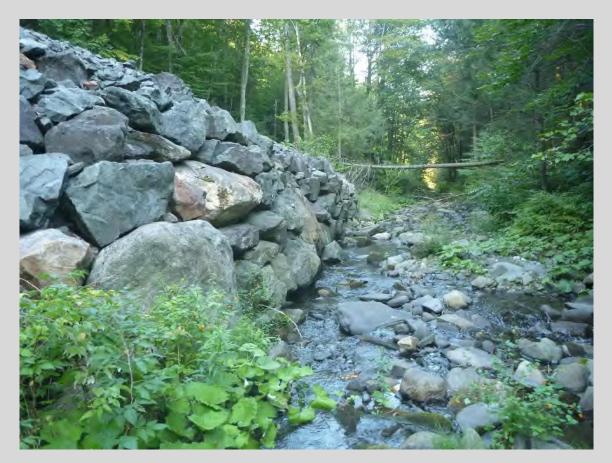
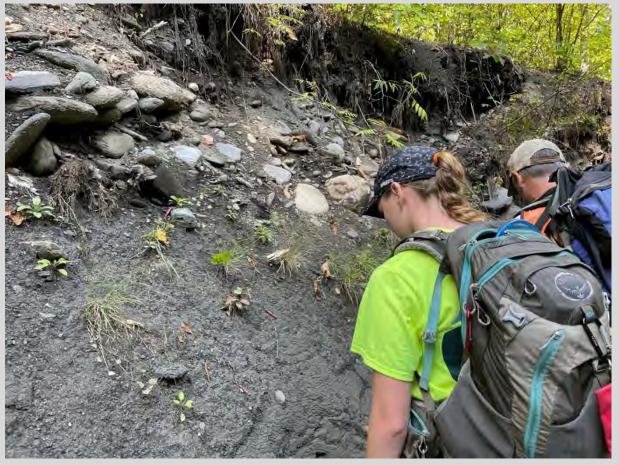
- Bank stability
 - Eroding banks 20%
 - Armored banks 15%

Looking at a deposit of glacial till on the right bank of the brook, which is a source of sedimentation

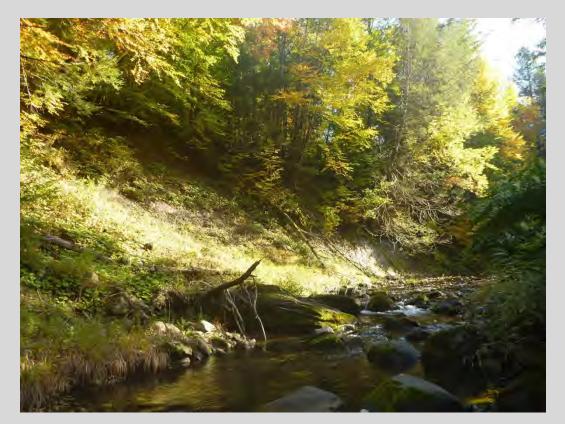
Mass failures (landslides)

- Major sediment source sediment loading and water quality impairments
- 28 mapped largest ~180 feet long and 40 feet high

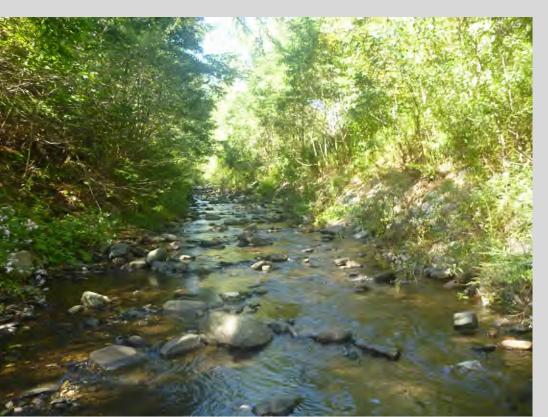
Channel straightening

- Long segments of stream are artificially straightened
- Increased slope = increased velocities and capacity to transport sediment
- Wood is unevenly distributed

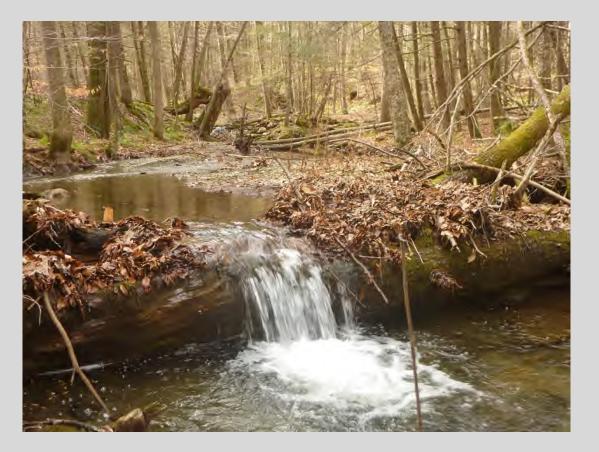
Individual pieces of wood and log jams mapped

- 1062 pieces
- 97 pcs/mile
- Natural conditions = 175 to 225 pcs/mile (McKinley et al., undated)
- Wood provides geomorphic and habitat benefits
 - Increased flow complexity
 - Sediment sorting and storage
 - Pool creation and maintenance
 - Provide cover habitat

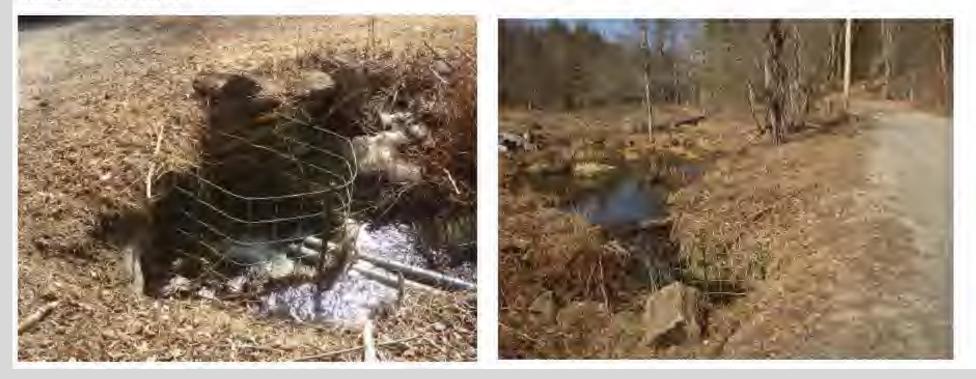
Project type: Road crossing upgrade/replacement Town: Buckland Location: Dodge Rd Lat/Long: 42.589006, -72.838216 Stream segment: Ruddock Brook

Culvert on Dodge Rd has failed multiple times washing out large portions of Dodge Rd (according to local residents) and continues to represent an extreme fluvial erosion hazard with a high likelihood of failure. Located at valley slope break with an extensive beaver pond complex upstream. Landowner has installed beaver deceiver devices to reduce likelihood of beavers clogging culvert inlet. Upgrade culvert to meet State stream crossing standards with bottomless arch, may include floodplain relief culverts.

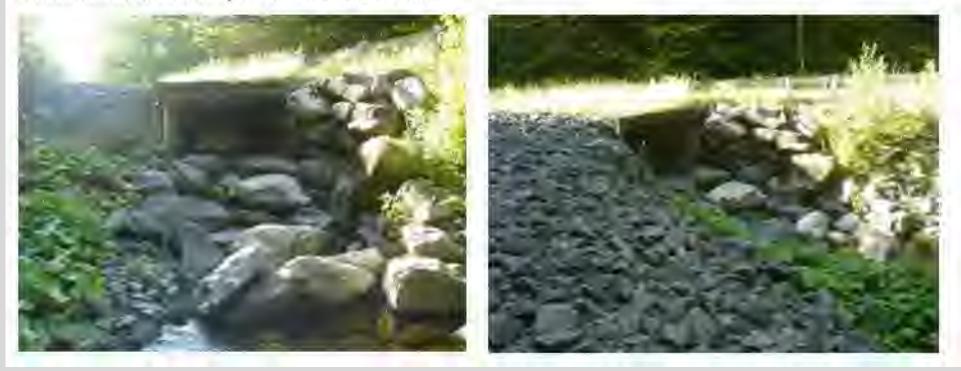
Project type: Road crossing upgrade/replacement Town: Hawley Location: Buckland Rd Lat/Long: 42.576646, -72.855391 Stream segment: Clesson Brook, CLE19B

Box culvert installed post-Irene is extreme fluvial erosion hazard with high likelihood of failure. Located at valley slope break downstream of artificially straightened channel. 6ft high by 12ft wide, perched 4 ft. Modeling shows overtopping at 10-year recurrence interval (R.I.) event. No aquatic organism passage (AOP). Replace culvert with bridge or bottomless arch, may include habitat structures upstream and downstream.

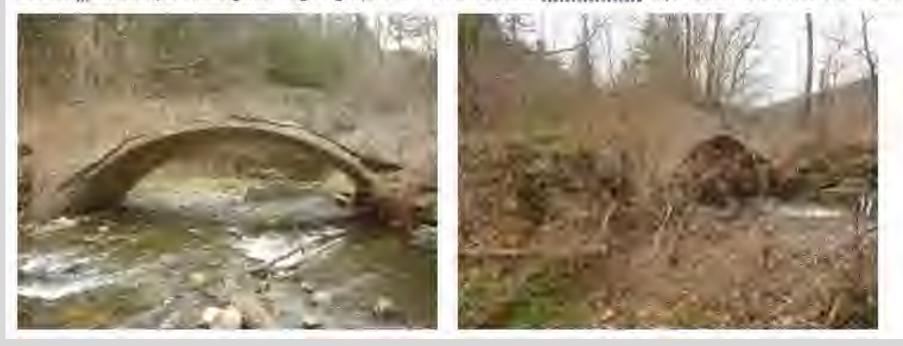
Project type: Remove bridge ruins/channel constriction Town: Buckland Location: Intersection of Route 112 and Old Hawley Rd Lat/Long: 42.570146, -72.802286 Stream segment: Clesson Brook, CLE11A

The bridge at the east end of Old Hawley Rd became clogged with sediment, wood, and debris during Tropical Storm Irene and an avulsion channel was carved around the bridge. The now ruined structure, which served one house, will likely not be repaired or replaced. The bridge ruins and roadway approaches constrict the channel and block portions of its floodplain representing a fluvial erosion hazard during high flow events. Remove the ruined structure and restore sediment transport and flood conveyance through the reach. Instream habitat structures may be installed to further restore geomorphic function. Invasive species mitigation targeting Japanese knotweed should be considered as part of the restoration of the site.

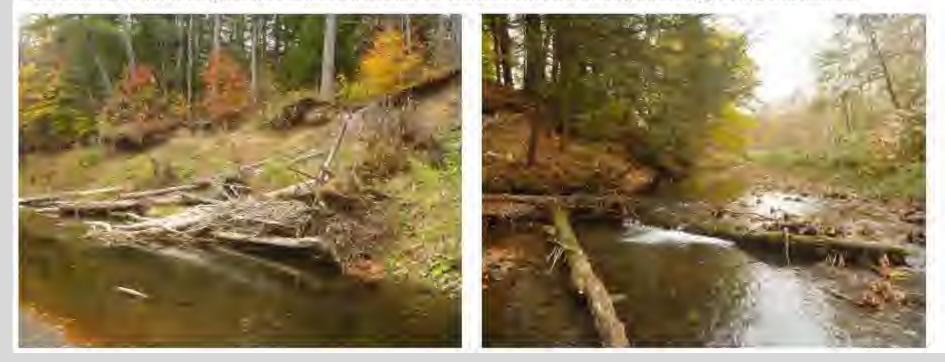
Project type: Mass failure stabilization, flow deflectors, bank cutting/flow diversion Town: Buckland Location: Near Buckland Recreation Area Lat/Long: 42.615840, -72.766073 Stream segment: Clesson Brook, CLE01

This dynamic reach, just upstream of the confluence with the Deerfield River, flows along the Buckland Recreation Area. Erosion of glacial banks threatens the recreation paths and high school running trails. The largest mass failure is approximately 20 feet high and 225 feet long and contributes a significant volume of sediment to lower Clesson Brook and the Deerfield River. Stabilize the toe of high bank using nature-based solutions and slope upper bank, before stabilizing with vegetation. Engineered log jams or log sills may be used to deflect flow away from the eroding bank. Side channel flow could be increased through bank cutting/flow diversion, which would divert flow into a low left bank channel and away from the mass failures. If permitting allows the mainstem channel could be diverted through more aggressive treatments.

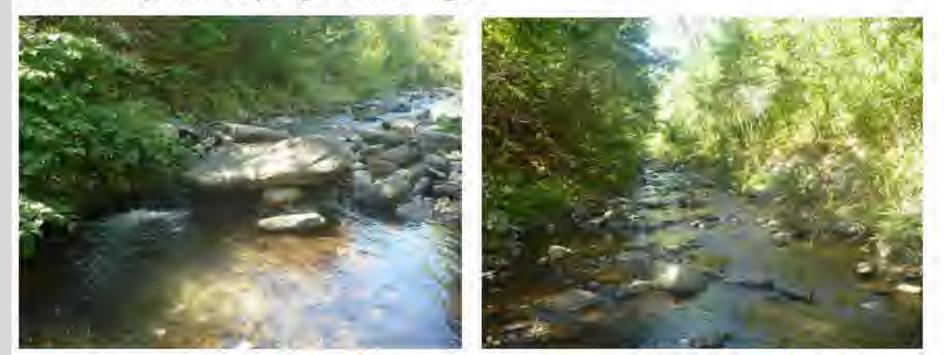
Prioritized List of Restoration Projects – Floodplain reconnection

Project type: Headcut stabilization, floodplain connection, and instream habitat structures Town: Buckland Location: Clesson Brook Rd ~0.5mi west of Shepard Rd Lat/Long: 42.580717, -72.825029 Stream segment: Clesson Brook, CLE15B

Vertical instability along Clesson Brook following excessive sediment mobilization and deposition during Tropical Storm Irene has resulted in a deeper channel with impaired floodplain connection and increased erosion hazards. Segment CLE15B includes six mapped headcuts and a windrow (berm) blocking a portion of the right bank floodplain. Install log sills to help arrest headcut migration and stabilize the bed. Boulder-supported log jams and other instream habitat structures encourage sediment sorting and deposition while enhancing habitat. These treatments are designed to slow flow velocities, encourage aggradation, and divert flows onto the right bank floodplain. Breaching the berm would further improve floodplain connection along this artificially straightened stream segment.

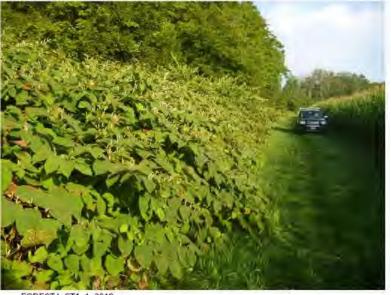
FOREST4_ST1_1_2019

Riparian buffer enhancement

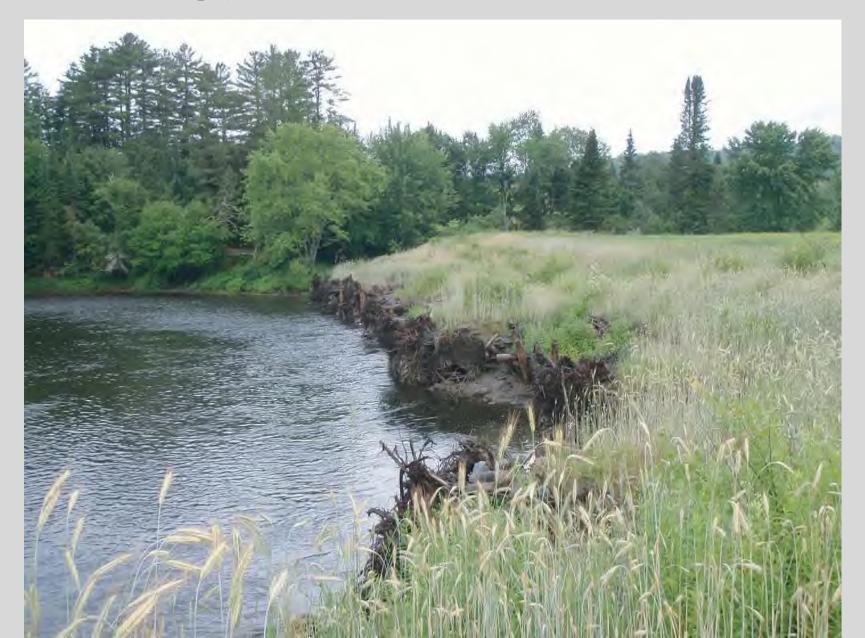
Log jams – Flow deflection

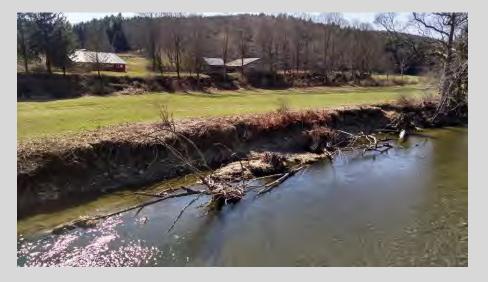
Wood buttress – Flow deflection

Before...

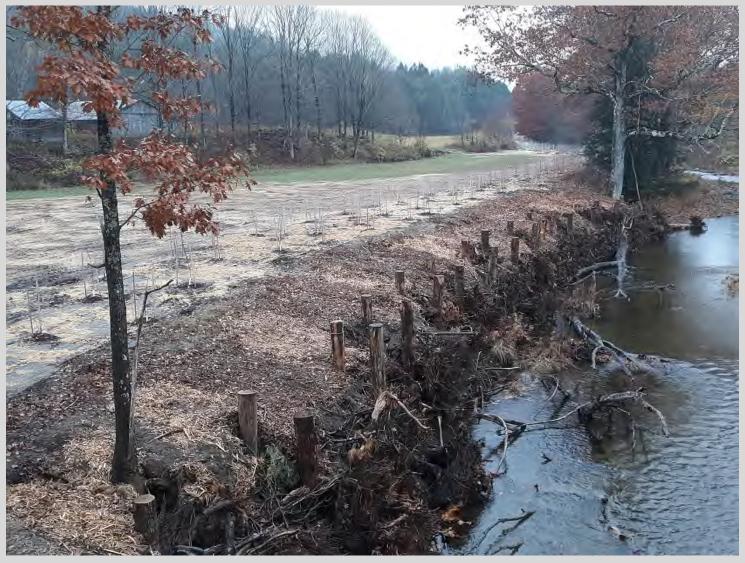
...and after

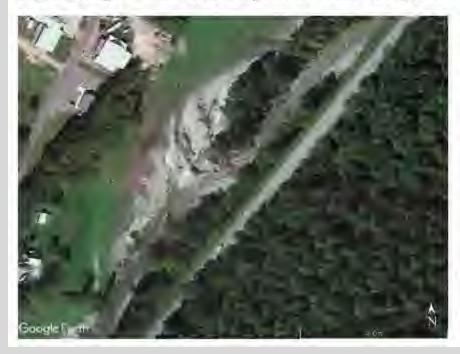
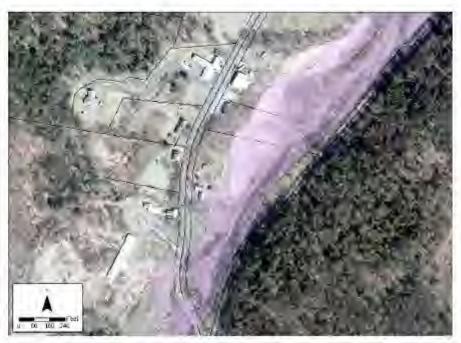
Prioritized List of Restoration Projects – River Corridor Easement

Project type: River Corridor Easement Town: Buckland Location: Downstream of Upper St bridge Lat/Long: 42.582525, -72.798309 Stream segment: Clesson Brook, CLE09

Low elevation floodplain divided into several parcels and currently in agricultural use. Site of a channel avulsion during Tropical Storm Irene, when sediment, wood, and debris were deposited (photo on left). Since, the stream has been "put back" into the straightened channel along Route 112. Hydraulic modeling data shows inundation at 10-year R.I. event (pink polygon in photo on right). Site is good candidate for a River Corridor Easement, a channel management and planning tool under development in Massachusetts, where landowners are compensated for allowing natural river processes (ie. flooding, sediment deposition, avulsions) to occur. This site could act as an asset for the village downstream by attenuating flood flows and allowing sediment to be deposited on the floodplain.

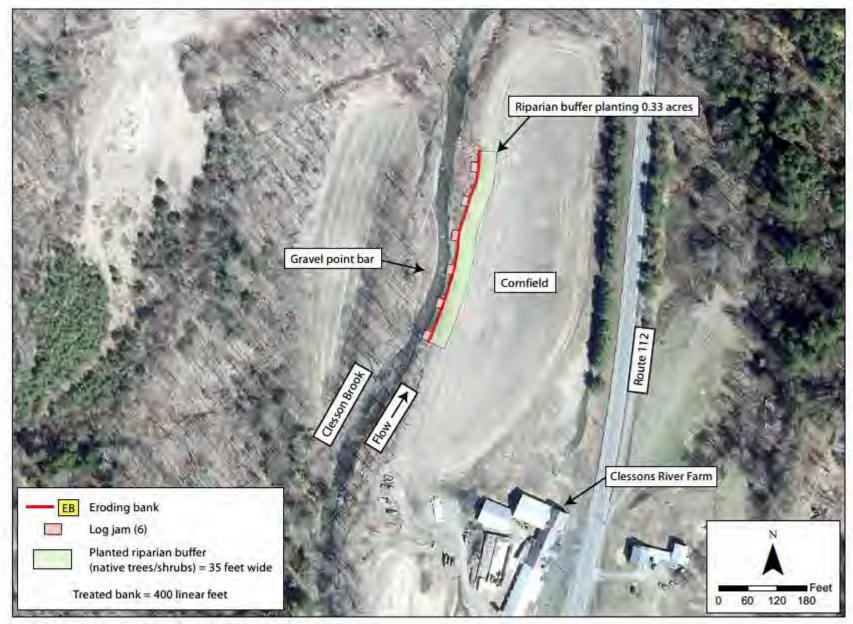
Clesson Brook - Clessons River Farm Site. Conceptual Design Plan View.

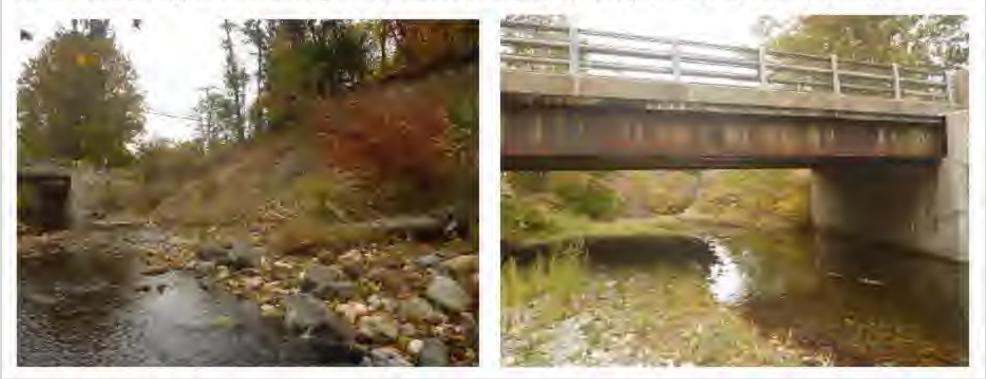
Project type: Road crossing upgrade/replacement and mass failure stabilization Town: Buckland Location: Route 112, Ashfield Rd Lat/Long: 42.613240, -72.768920 Stream segment: Clesson Brook, CLE03A

Undersized MassDOT bridge (#B28004) is extreme fluvial erosion hazard with risk of clogging with sediment from adjacent and upstream mass failures. Located downstream of artificially straightened channel and at angle to stream channel. Sediment deposition inside structure and along left abutment limits hydraulic capacity. Significant scour at right bank abutment. Significant rust on steel span. Low clearance at upstream opening. Modeling shows overtopping at 10-year R.I. event. Replace bridge with increased span and increased clearance, add floodplain culverts, and stabilize mass failure.

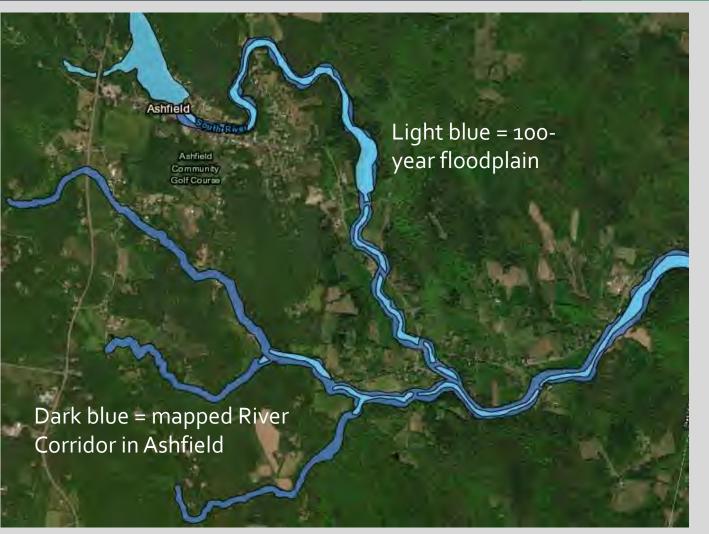
The mapped river corridor shows the room a river needs and the land vulnerable to flooding and fluvial erosion. The 100-year floodplain maps produced by FEMA do not address fluvial erosion hazards.
